Access Compliance Report

Public Rights-of-Way

(Curb Ramps)

| Intersection ID: 50706 | Main Street: GENERATIONS_ST | Cross Street: BROTHERLY_LN | Location: SE |

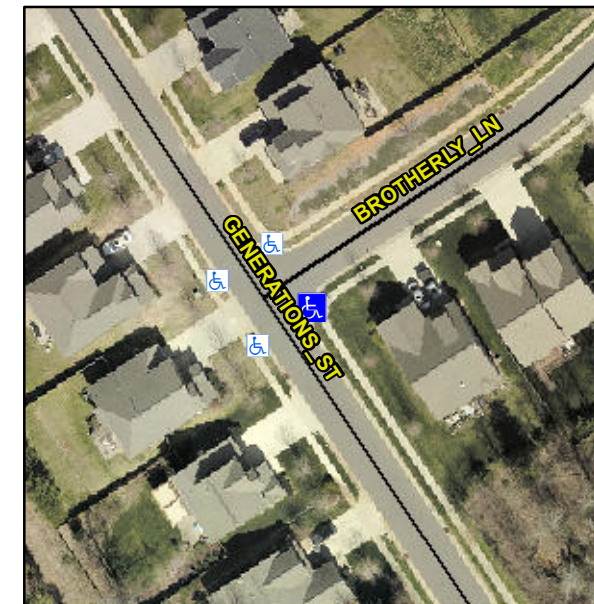
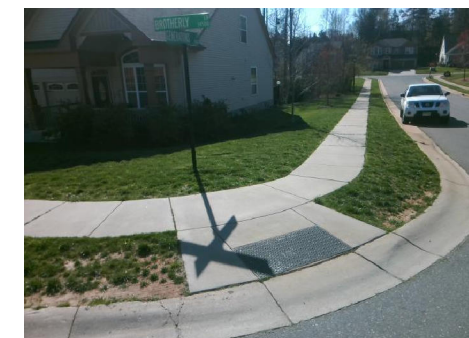
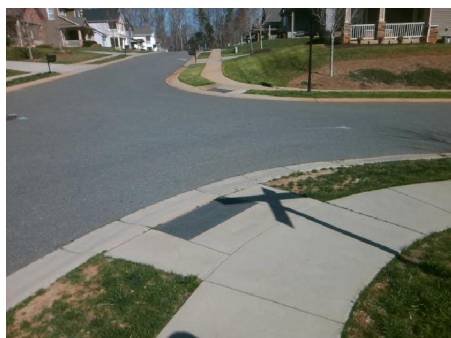
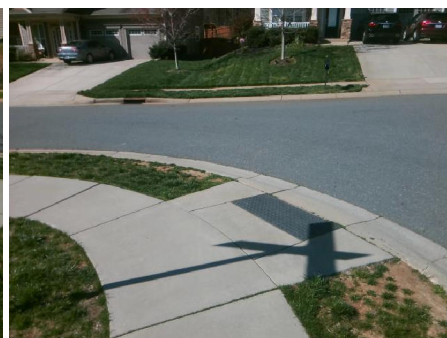
| ADA ID: 5460789B2784 | Ramp Type: PerpDiag | Initial Pass/Fail: Fail | Overall Compliance: No |
| Severity Score: 21.25 | | | |

Not Found, R304.5.1, R304.2.2

| Compliance | Description | Data | Compliance | Description | Data |
|---|---|---|---|---|---|
| N/A | Ramp Length (in) | 48.0 | No | Ramp Slope (%) | 8.6 |
| No | Ramp Width (in) | 47.5 | Yes | Ramp XSlope (%) | 0.5 |

Remove & Replace Curb Ramp With Two New Directional Ramps or Equivalent.
