Access Compliance Report

Public Rights-of-Way

(Curb Ramps)

Intersection ID: 10029688	Main Street: KINGSLEY_VIEW_DR	Cross Street: N/A	Location: SE
ADA ID: 5460A553F545	Ramp Type: PerpDiag	Initial Pass/Fail: Fail	Overall Compliance: No
Codes/Mitigation Info/Possible Solution		Field Measurements/Component Compliance	
Severity Score: 25

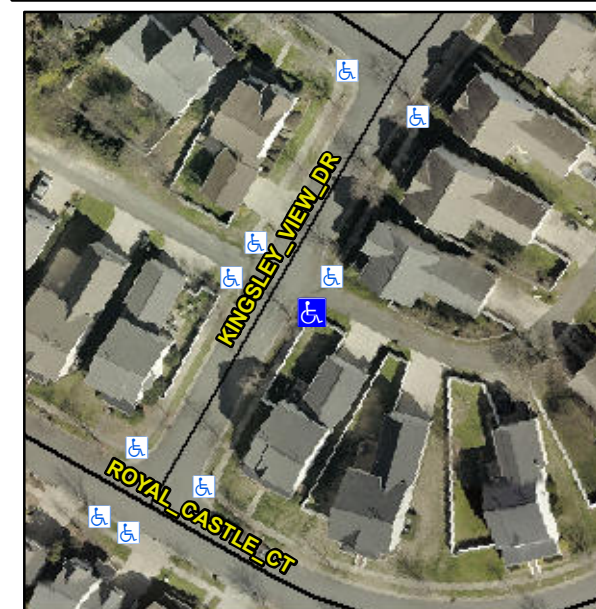
R304.5.3

Compliance	Description	Data	Compliance	Description	Data
N/A	Ramp Length (in)	36.0	Yes	Ramp Slope (%)	6.1
Yes	Ramp Width (in)	48.0	No	Ramp XSlope (%)	9.6
N/A	Flare Type LT	N/A	N/A	Flare Type RT	N/A
N/A	Flare Slope LT (%)	N/A	N/A	Flare Slope RT (%)	N/A
N/A	Flare Traversable LT?	N/A	N/A	Flare Traversable RT?	N/A
N/A	Landing Length (in)	N/A	N/A	DWS Provided?	N/A
N/A	Landing Width (in)	N/A	N/A	DWS Contrast?	N/A
N/A	Landing Slope (%)	N/A	N/A	DWS Length (in)	N/A
N/A	Landing X Slope (%)	N/A	N/A	DWS Full Width?	N/A
N/A	Landing Curb? (Y/N)	N/A	N/A	DWS Offset (in)	N/A
N/A	Shared Landing?	N/A			
N/A	Gutter Ponding?	N/A	N/A	Gutter Slope (%)	N/A
N/A	Gutter Lip Ht (in)	N/A	N/A	Gutter X Slope (%)	N/A
N/A	Painted X Walk1?	No	N/A	Painted X Walk2?	No
	X Walk 1 Direction	To NE		X Walk 2 Direction	To NW
N/A	X Walk 1 Width (in)	N/A	N/A	X Walk 2 Width (in)	N/A
	X Walk 1 Slope (%)	3.1		X Walk 2 Slope (%)	4.0
	X Walk 1 X Slope (%)	4.2		X Walk 2 X Slope (%)	8.4

N/A	Ramp inside XWalk1?	N/A	N/A	Ramp inside XWalk2?	N/A
	Road Slope (%)	5.5	N/A	Clear Space?	N/A
	Road X Slope (%)	4.5	N/A	Clear Space to XWalk (in)	N/A
N/A	Any Obstructions?	N/A	N/A	Storm Grate/Utility Hazard?	N/A
	Obstruction Type			Storm Grate/Utility Type	
		N/A			N/A
			Yes	Surface Condition? (G/P)	Good

Possible Solutions:

Remove & Replace Curb Ramp With Two New Directional Ramps or Equivalent.
