Access Compliance Report

Public Rights-of-Way

(Curb Ramps)

Intersection ID: 26051	Main Street: BANNINGTON_RD	Cross Street: POPPY_HILLS_LN	Location: SW
ADA ID: 54663F05EC99	Ramp Type: PerpDiag	Initial Pass/Fail: Fail	Overall Compliance: No
Severity Score: 35			
Codes/Mitigation Info/Possible Solution		Field Measurements/Component Compliance

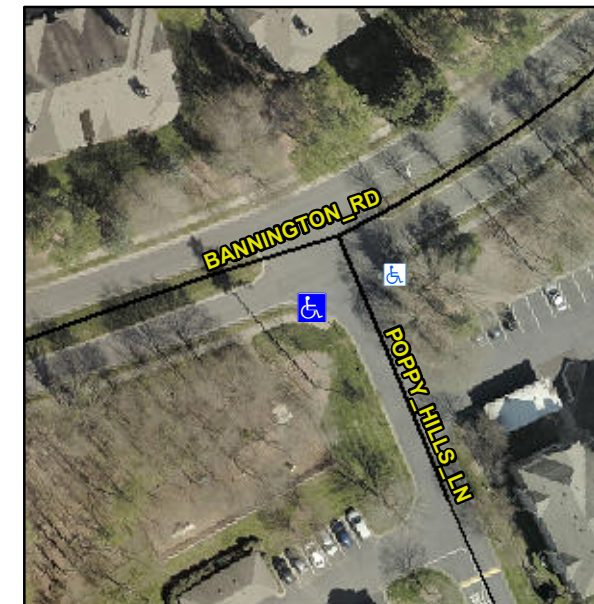
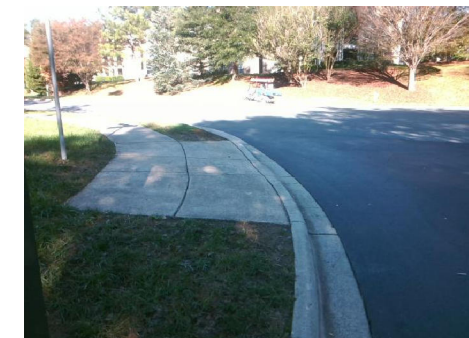
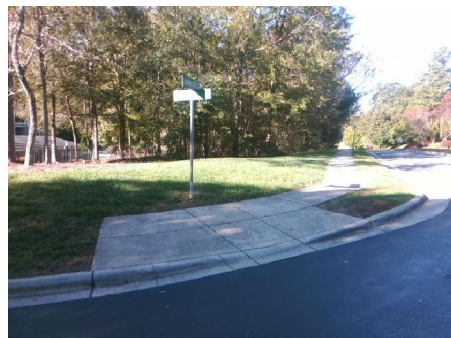
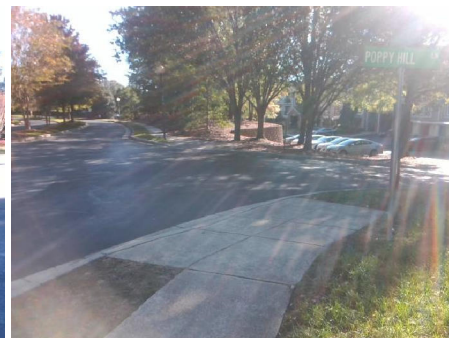
Not Found, R304.5.1, R304.2.2, R304.5.3

Compliance	Description	Data	Compliance	Description	Data
N/A	Ramp Length (in)	92.0	No	Ramp Slope (%)	12.7
No	Ramp Width (in)	39.0	No	Ramp XSlope (%)	4.0
N/A	Flare Type LT	N/A	N/A	Flare Type RT	N/A
N/A	Flare Slope LT (%)	N/A	N/A	Flare Slope RT (%)	N/A
N/A	Flare Traversable LT?	N/A	N/A	Flare Traversable RT?	N/A
N/A	Landing Length (in)	N/A	N/A	DWS Provided?	N/A
N/A	Landing Width (in)	N/A	N/A	DWS Contrast?	N/A
N/A	Landing Slope (%)	N/A	N/A	DWS Length (in)	N/A
N/A	Landing X Slope (%)	N/A	N/A	DWS Full Width?	N/A
N/A	Landing Curb? (Y/N)	N/A	N/A	DWS Offset (in)	N/A
N/A	Shared Landing?	N/A			
N/A	Gutter Ponding?	N/A	N/A	Gutter Slope (%)	N/A
N/A	Gutter Lip Ht (in)	N/A	N/A	Gutter X Slope (%)	N/A
N/A	Painted X Walk1?	No	N/A	Painted X Walk2?	No
	X Walk 1 Direction	To E		X Walk 2 Direction	To N
N/A	X Walk 1 Width (in)	N/A	N/A	X Walk 2 Width (in)	N/A
	X Walk 1 Slope (%)	0.4		X Walk 2 Slope (%)	5.6
	X Walk 1 X Slope (%)	5.1		X Walk 2 X Slope (%)	1.0

N/A	Ramp inside XWalk1?	N/A	N/A	Ramp inside XWalk2?	N/A
	Road Slope (%)	4.8	N/A	Clear Space?	N/A
	Road X Slope (%)	2.3	N/A	Clear Space to XWalk (in)	N/A
N/A	Any Obstructions?	N/A	N/A	Storm Grate/Utility Hazard?	N/A
	Obstruction Type			Storm Grate/Utility Type	
		N/A			N/A
			Yes	Surface Condition? (G/P)	Good

Remove & Replace Curb Ramp With Two New Directional Ramps or Equivalent.

Total Cost: \$ 3200.00
