# Access Compliance Report

## Public Rights-of-Way

### (Curb Ramps)

Intersection ID: 12054	Main Street: MCNINCH_ST	Cross Street: W_HILL_ST	Location: S
ADA ID: 54705BAB3693	Ramp Type: Perp	Initial Pass/Fail: Pass	Overall Compliance: No
Severity Score: 5			
Codes/Mitigation Info/Possible Solution		Field Measurements/Component Compliance

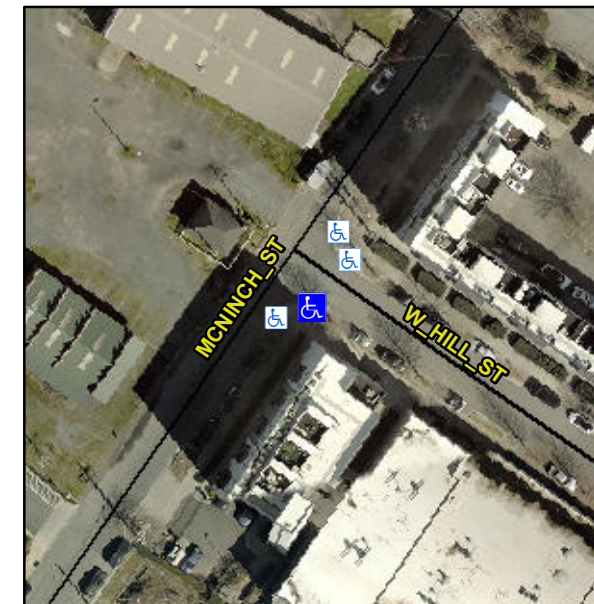
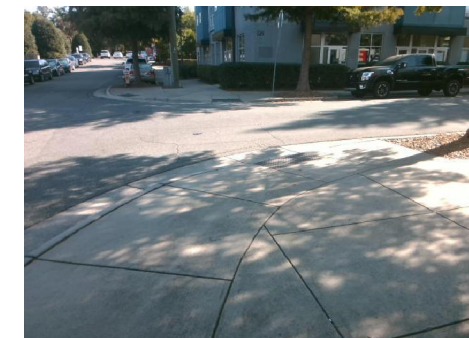
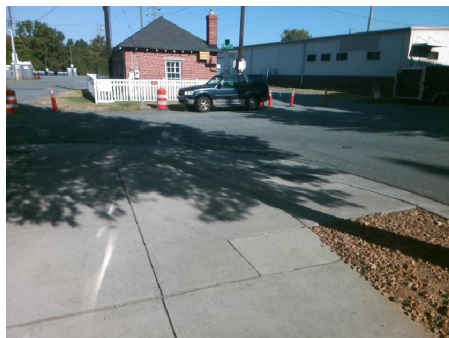
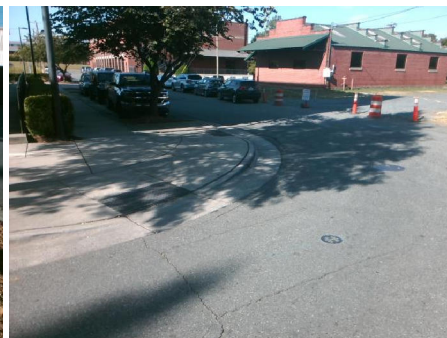
**Not Found, R304.5.4**

Compliance	Description	Data	Compliance	Description	Data
N/A	Ramp Length (in)	67.0	Yes	Ramp Slope (%)	6.4
Yes	Ramp Width (in)	48.0	Yes	Ramp XSlope (%)	1.6
N/A	Flare Type LT	Sloped	N/A	Flare Type RT	N/A
N/A	Flare Slope LT (%)	7.6	Yes	Flare Slope RT (%)	3.5
N/A	Flare Traversable LT?	Yes	N/A	Flare Traversable RT?	Yes
Yes	Landing Length (in)	60.0	Yes	DWS Provided?	Yes
Yes	Landing Width (in)	48.0	Yes	DWS Contrast?	Yes
Yes	Landing Slope (%)	1.0	Yes	DWS Length (in)	24.0
Yes	Landing X Slope (%)	0.3	Yes	DWS Full Width?	Yes
N/A	Landing Curb? (Y/N)	No	Yes	DWS Offset (in)	1.0
N/A	Shared Landing?	No			
Yes	Gutter Ponding?	No	No	Gutter Slope (%)	5.5
Yes	Gutter Lip Ht (in)	0.0	Yes	Gutter X Slope (%)	0.7
N/A	Painted X Walk1?	No	N/A	Painted X Walk2?	N/A
	X Walk 1 Direction	To NE		X Walk 2 Direction	N/A
N/A	X Walk 1 Width (in)	N/A	N/A	X Walk 2 Width (in)	N/A
	X Walk 1 Slope (%)	7.8		X Walk 2 Slope (%)	N/A
	X Walk 1 X Slope (%)	0.5		X Walk 2 X Slope (%)	N/A

N/A	Ramp inside XWalk1?	N/A	N/A	Ramp inside XWalk2?	N/A
	Road Slope (%)	N/A	N/A	Clear Space?	Yes
	Road X Slope (%)	N/A	N/A	Clear Space to XWalk (in)	N/A
Yes	Any Obstructions?	No	Yes	Storm Grate/Utility Hazard?	No
	Obstruction Type			Storm Grate/Utility Type	
		N/A			N/A
			Yes	Surface Condition? (G/P)	Good

**Remove & Replace Entire Ramp.  
Remove & Replace Gutter.**

Total Cost: \$ 2600.00
