Access Compliance Report

Public Rights-of-Way

(Curb Ramps)

Intersection ID: 10035869	Main Street: REXFORD_RD	Cross Street: N/A	Location: NE
ADA ID: 547B38A3D335	Ramp Type: Perp	Initial Pass/Fail: Fail	Overall Compliance: No
Severity Score: 25			
Codes/Mitigation Info/Possible Solution		Field Measurements/Component Compliance

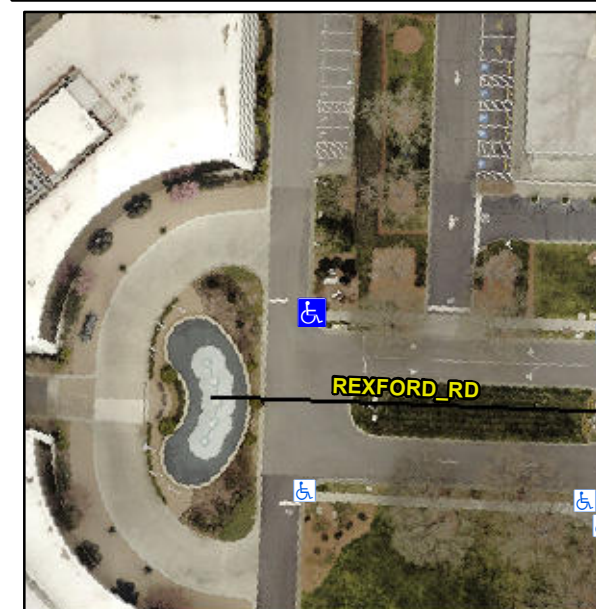
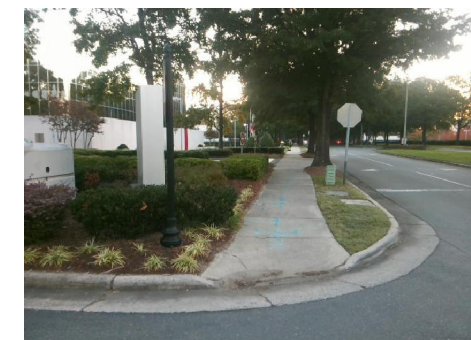
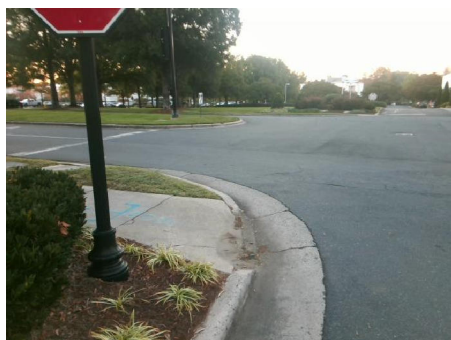
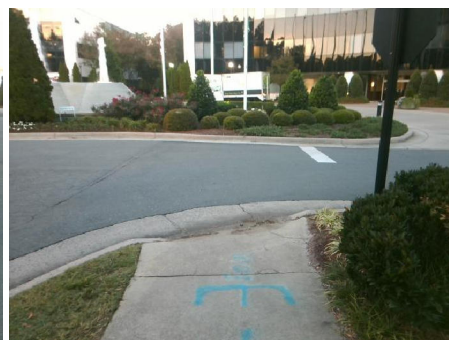
Compliance	Description	Data	Compliance	Description	Data
N/A	Ramp Length (in)	55.0	No	Ramp Slope (%)	13.2
Yes	Ramp Width (in)	48.0	Yes	Ramp XSlope (%)	0.7
N/A	Flare Type LT	N/A	N/A	Flare Type RT	N/A
N/A	Flare Slope LT (%)	N/A	N/A	Flare Slope RT (%)	N/A
N/A	Flare Traversable LT?	N/A	N/A	Flare Traversable RT?	N/A
N/A	Landing Length (in)	N/A	N/A	DWS Provided?	N/A
N/A	Landing Width (in)	N/A	N/A	DWS Contrast?	N/A
N/A	Landing Slope (%)	N/A	N/A	DWS Length (in)	N/A
N/A	Landing X Slope (%)	N/A	N/A	DWS Full Width?	N/A
N/A	Landing Curb? (Y/N)	N/A	N/A	DWS Offset (in)	N/A
N/A	Shared Landing?	N/A			
N/A	Gutter Ponding?	N/A	N/A	Gutter Slope (%)	N/A
N/A	Gutter Lip Ht (in)	N/A	N/A	Gutter X Slope (%)	N/A
N/A	Painted X Walk1?	No	N/A	Painted X Walk2?	N/A
	X Walk 1 Direction	To W		X Walk 2 Direction	N/A
N/A	X Walk 1 Width (in)	N/A	N/A	X Walk 2 Width (in)	N/A
	X Walk 1 Slope (%)	2.7		X Walk 2 Slope (%)	N/A
	X Walk 1 X Slope (%)	2.2		X Walk 2 X Slope (%)	N/A

Possible Solutions:

Remove & Replace Entire Ramp.

R304.2.2
