Access Compliance Report

Public Rights-of-Way

(Curb Ramps)

Intersection ID: 6203	Main Street: CRANDON_DR	Cross Street: PEACHWOOD_DR	Location: SW
ADA ID: 5481E482B9E3	Ramp Type: BlendTrans1	Initial Pass/Fail: Fail	Overall Compliance: No
		Severity Score: 8.75

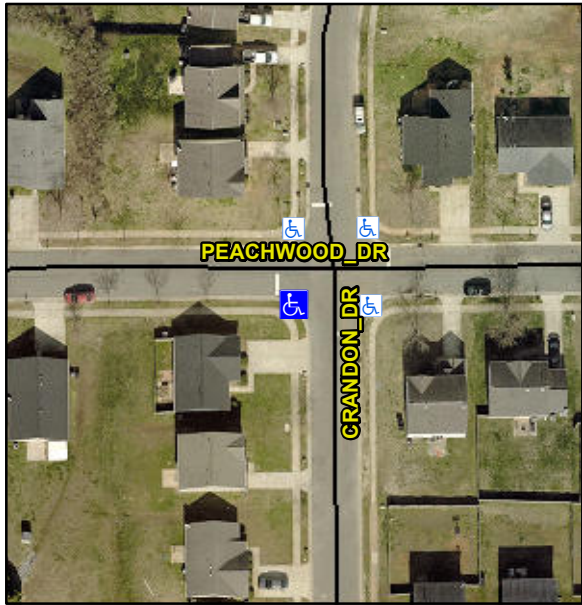
Possible Solutions:		Compliance	Description	Data	Compliance	Description	Data
	Remove & Replace Curb Ramp With Two New Directional Ramps or Equivalent.		N/A	Ramp Length (in)	49.0	Yes	BlendTrans Slope (%)	4.8
			No	Ramp Width (in)	44.0	Yes	BlendTrans XSlope (%)	0.6
			N/A	Flare Type LT	N/A	N/A	Flare Type RT	N/A
			N/A	Flare Slope LT (%)	N/A	N/A	Flare Slope RT (%)	N/A
			N/A	Flare Traversable LT?	N/A	N/A	Flare Traversable RT?	N/A
			N/A	Landing Length (in)	N/A	N/A	DWS Provided?	N/A
			N/A	Landing Width (in)	N/A	N/A	DWS Contrast?	N/A
			N/A	Landing Slope (%)	N/A	N/A	DWS Length (in)	N/A
			N/A	Landing X Slope (%)	N/A	N/A	DWS Full Width?	N/A
<p>Surveyor Notes:</p> <p>N/A</p>	PROW/ADA:		N/A	Landing Curb? (Y/N)	N/A	N/A	DWS Offset (in)	N/A
	Not Found, R304.5.1		N/A	Shared Landing?	N/A			
			N/A	Gutter Ponding?	N/A	N/A	Gutter Slope (%)	N/A

N/A	Gutter Lip Ht (in)	N/A	N/A	Gutter X Slope (%)	N/A
			N/A	Painted X Walk1?	No	N/A	Painted X Walk2?	No
				X Walk 1 Direction	To E		X Walk 2 Direction	To N
				X Walk 1 Width (in)	N/A		X Walk 2 Width (in)	N/A
				X Walk 1 Slope (%)	3.2		X Walk 2 Slope (%)	4.6
				X Walk 1 X Slope (%)	2.9		X Walk 2 X Slope (%)	1.0
			N/A	Ramp inside XWalk1?	N/A	N/A	Ramp inside XWalk2?	N/A
			Road Slope (%)	1.1		Clear Space?	N/A	
			Road X Slope (%)	4.8	N/A	Clear Space to XWalk (in)	N/A	
		N/A	Any Obstructions?	N/A	N/A	Storm Grate/Utility Hazard?	N/A	
			Obstruction Type			Storm Grate/Utility Type		
					N/A			N/A
					Yes	Surface Condition? (G/P)	Good	
					No	Curb Slope (%)	11.2	
					</
