Access Compliance Report

Public Rights-of-Way

(Curb Ramps)

Intersection ID: 9801	Main Street: ETHEL_GUEST_LN	Cross Street: RISING_OAK_DR	Location: NE
ADA ID: 548C41000FF6	Ramp Type: Perp	Initial Pass/Fail: Fail	Overall Compliance: No
Severity Score: 10			
Codes/Mitigation Info/Possible Solution		Field Measurements/Component Compliance

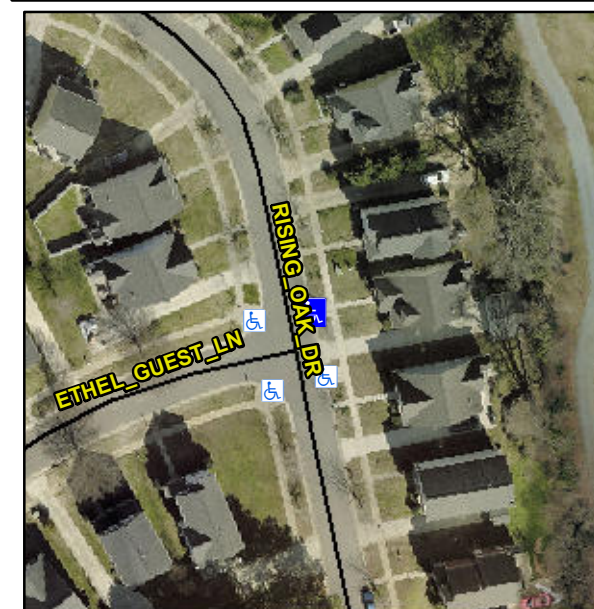
Not Found, R304.5.1, R304.5.3

Compliance	Description	Data	Compliance	Description	Data
N/A	Ramp Length (in)	95.0	Yes	Ramp Slope (%)	5.2
No	Ramp Width (in)	47.0	No	Ramp XSlope (%)	3.7
N/A	Flare Type LT	N/A	N/A	Flare Type RT	N/A
N/A	Flare Slope LT (%)	N/A	N/A	Flare Slope RT (%)	N/A
N/A	Flare Traversable LT?	N/A	N/A	Flare Traversable RT?	N/A
N/A	Landing Length (in)	N/A	N/A	DWS Provided?	N/A
N/A	Landing Width (in)	N/A	N/A	DWS Contrast?	N/A
N/A	Landing Slope (%)	N/A	N/A	DWS Length (in)	N/A
N/A	Landing X Slope (%)	N/A	N/A	DWS Full Width?	N/A
N/A	Landing Curb? (Y/N)	N/A	N/A	DWS Offset (in)	N/A
N/A	Shared Landing?	N/A			
N/A	Gutter Ponding?	N/A	N/A	Gutter Slope (%)	N/A
N/A	Gutter Lip Ht (in)	N/A	N/A	Gutter X Slope (%)	N/A
N/A	Painted X Walk1?	No	N/A	Painted X Walk2?	N/A
	X Walk 1 Direction	To W		X Walk 2 Direction	N/A
N/A	X Walk 1 Width (in)	N/A	N/A	X Walk 2 Width (in)	N/A
	X Walk 1 Slope (%)	1.4		X Walk 2 Slope (%)	N/A
	X Walk 1 X Slope (%)	3.2		X Walk 2 X Slope (%)	N/A

N/A	Ramp inside XWalk1?	N/A	N/A	Ramp inside XWalk2?	N/A
	Road Slope (%)	N/A	N/A	Clear Space?	N/A
	Road X Slope (%)	N/A	N/A	Clear Space to XWalk (in)	N/A
N/A	Any Obstructions?	N/A	N/A	Storm Grate/Utility Hazard?	N/A
	Obstruction Type			Storm Grate/Utility Type	
		N/A			N/A
			Yes	Surface Condition? (G/P)	Good

Possible Solutions:

Remove & Replace Entire Ramp.
