Access Compliance Report

Public Rights-of-Way

(Curb Ramps)

Intersection ID: 50470	Main Street: EVERTON_DR	Cross Street: LENOX_POINTE_DR	Location: NE
ADA ID: 548F91920648	Ramp Type: Perp	Initial Pass/Fail: Pass	Overall Compliance: No
Severity Score: 0			
Codes/Mitigation Info/Possible Solution		Field Measurements/Component Compliance

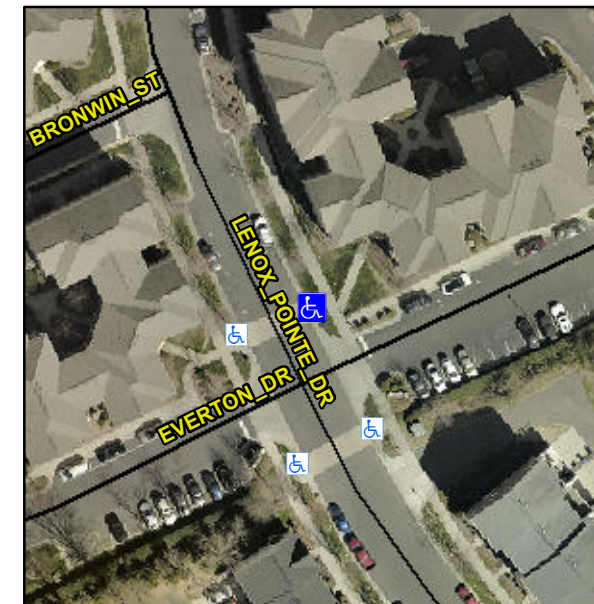
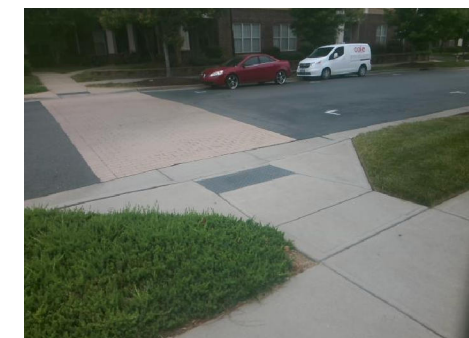
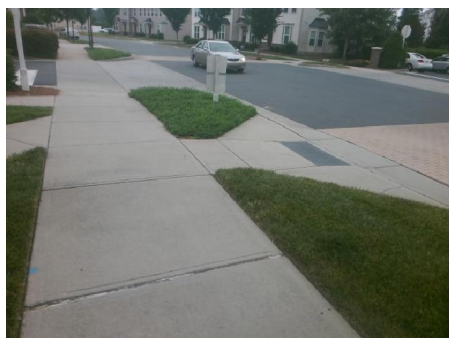
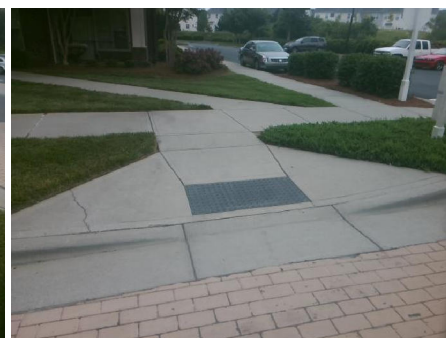
Not Found, R305.2

Compliance	Description	Data	Compliance	Description	Data
N/A	Ramp Length (in)	98.0	Yes	Ramp Slope (%)	6.0
Yes	Ramp Width (in)	59.5	Yes	Ramp XSlope (%)	1.2
N/A	Flare Type LT	Sloped	N/A	Flare Type RT	N/A
N/A	Flare Slope LT (%)	3.2	N/A	Flare Slope RT (%)	5.5
N/A	Flare Traversable LT?	No	N/A	Flare Traversable RT?	No
Yes	Landing Length (in)	72.0	Yes	DWS Provided?	Yes
Yes	Landing Width (in)	58.0	Yes	DWS Contrast?	Yes
Yes	Landing Slope (%)	1.0	Yes	DWS Length (in)	24.0
Yes	Landing X Slope (%)	0.3	Yes	DWS Full Width?	Yes
N/A	Landing Curb? (Y/N)	No	No	DWS Offset (in)	4.5
N/A	Shared Landing?	No			
Yes	Gutter Ponding?	No	Yes	Gutter Slope (%)	1.9
Yes	Gutter Lip Ht (in)	0.0	Yes	Gutter X Slope (%)	1.2
N/A	Painted X Walk1?	Yes	N/A	Painted X Walk2?	N/A
	X Walk 1 Direction	To W		X Walk 2 Direction	N/A
N/A	X Walk 1 Width (in)	144.0	N/A	X Walk 2 Width (in)	N/A
	X Walk 1 Slope (%)	0.7		X Walk 2 Slope (%)	N/A
	X Walk 1 X Slope (%)	0.3		X Walk 2 X Slope (%)	N/A

Yes	Ramp inside XWalk1?	Yes	N/A	Ramp inside XWalk2?	N/A
	Road Slope (%)	N/A	N/A	Clear Space?	Yes
	Road X Slope (%)	N/A	N/A	Clear Space to XWalk (in)	N/A
Yes	Any Obstructions?	No	Yes	Storm Grate/Utility Hazard?	No
	Obstruction Type			Storm Grate/Utility Type	
		N/A			N/A
			Yes	Surface Condition? (G/P)	Good

Remove & Replace Entire Ramp.
