Access Compliance Report Public Rights-of-Way (Curb Ramps)

Intersection ID: 10034710 Main Street: POINDEXTER DR Cross Street: N/A Location: S Initial Pass/Fail: Fail **Overall Compliance: No Severity Score:** 12.5 ADA ID: 549D32B12C5E Ramp Type: Perp

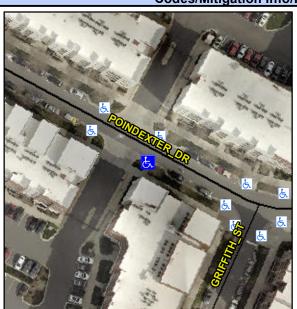
POINDEXTER DR Street 1 Name Stop Condition-Street 2 None N/A Street 2 Name Stop Condition-Street 1 N/A Possible Solutions: Remove & Replace Entire Ramp. Surveyor Notes: N/A PROW/ADA: R304.2.2
