Access Compliance Report

Public Rights-of-Way

(Curb Ramps)

Intersection ID: 29459	Main Street: N_ALEXANDER_ST	Cross Street: GARDEN_DISTRICT_DR	Location: E
ADA ID: 549E57F5CB8A	Ramp Type: BlendTrans1	Initial Pass/Fail: Fail	Overall Compliance: No
			Severity Score: 21.25

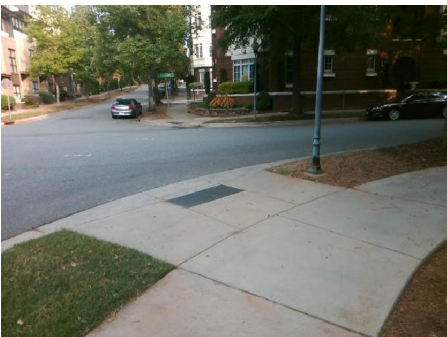
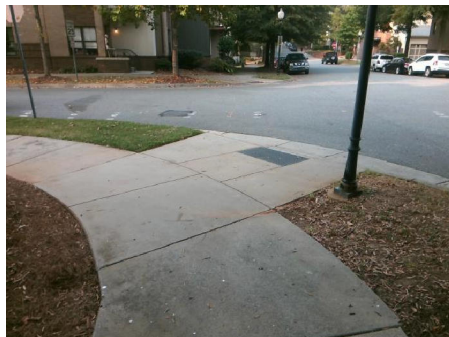
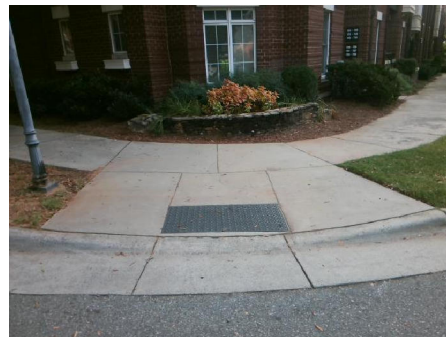
Not Found, R304.5.1, R304.5.3

Compliance	Description	Data	Compliance	Description	Data
N/A	Ramp Length (in)	73.0	Yes	BlendTrans Slope (%)	0.7
No	Ramp Width (in)	47.5	No	BlendTrans XSlope (%)	5.5
N/A	Flare Type LT	N/A	N/A	Flare Type RT	N/A
N/A	Flare Slope LT (%)	N/A	N/A	Flare Slope RT (%)	N/A
N/A	Flare Traversable LT?	N/A	N/A	Flare Traversable RT?	N/A
N/A	Landing Length (in)	N/A	N/A	DWS Provided?	N/A
N/A	Landing Width (in)	N/A	N/A	DWS Contrast?	N/A
N/A	Landing Slope (%)	N/A	N/A	DWS Length (in)	N/A
N/A	Landing X Slope (%)	N/A	N/A	DWS Full Width?	N/A
N/A	Landing Curb? (Y/N)	N/A	N/A	DWS Offset (in)	N/A
N/A	Shared Landing?	N/A			
N/A	Gutter Ponding?	N/A	N/A	Gutter Slope (%)	N/A
N/A	Gutter Lip Ht (in)	N/A	N/A	Gutter X Slope (%)	N/A
N/A	Painted X Walk1?	No	N/A	Painted X Walk2?	No
	X Walk 1 Direction	To NW		X Walk 2 Direction	To SW
	X Walk 1 Width (in)	N/A		X Walk 2 Width (in)	N/A
	X Walk 1 Slope (%)	4.1		X Walk 2 Slope (%)	0.3
	X Walk 1 X Slope (%)	3.0		X Walk 2 X Slope (%)	3.5

N/A	Ramp inside XWalk1?	N/A	N/A	Ramp inside XWalk2?	N/A
	Road Slope (%)	4.9		Clear Space?	N/A
	Road X Slope (%)	0.1	N/A	Clear Space to XWalk (in)	N/A
N/A	Any Obstructions?	N/A	N/A	Storm Grate/Utility Hazard?	N/A
	Obstruction Type			Storm Grate/Utility Type	
		N/A			N/A
			Yes	Surface Condition? (G/P)	Good
			No	Curb Slope (%)	9.5

Remove & Replace Curb Ramp With Two New Directional Ramps or Equivalent.
