Access Compliance Report

Public Rights-of-Way

(Curb Ramps)

Intersection ID: 27556	Main Street: LEDERER_AV	Cross Street: QUEARY_CT	Location: NW
ADA ID: 54A05ED0ED4A	Ramp Type: BlendTrans2	Initial Pass/Fail: Fail	Overall Compliance: No
Severity Score: 12.5			
Codes/Mitigation Info/Possible Solution		Field Measurements/Component Compliance

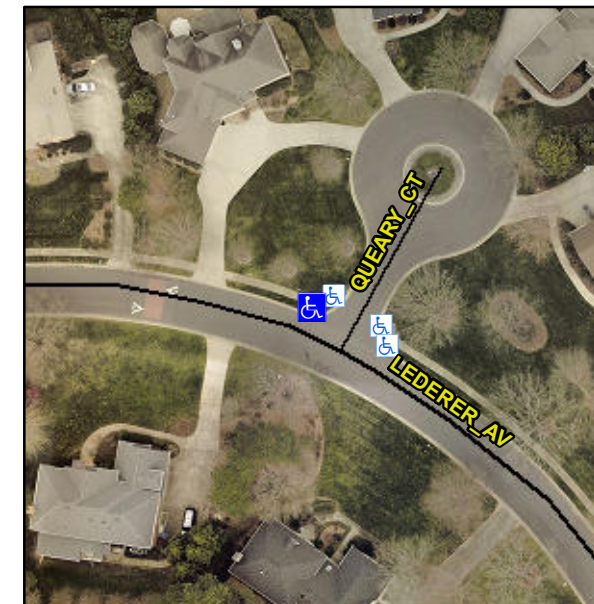
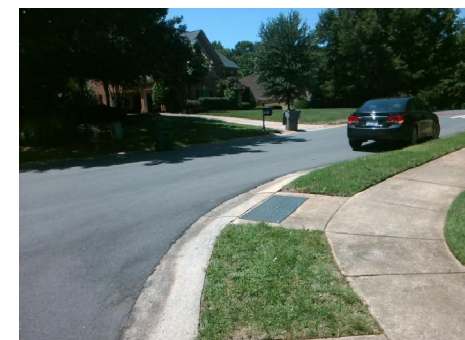
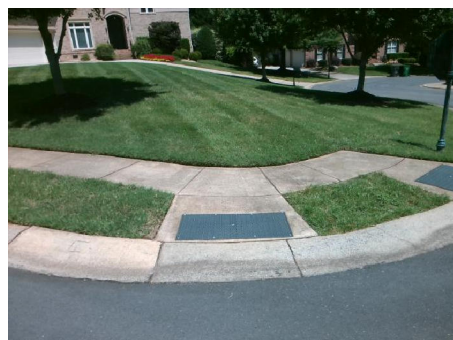
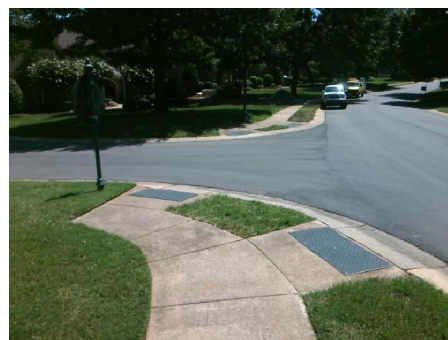
Not Found, R304.5.3

Compliance	Description	Data	Compliance	Description	Data
N/A	Ramp Length (in)	48.0	Yes	BlendTrans Slope (%)	0.4
Yes	Ramp Width (in)	48.0	No	BlendTrans XSlope (%)	6.3
N/A	Flare Type LT	N/A	N/A	Flare Type RT	N/A
N/A	Flare Slope LT (%)	N/A	N/A	Flare Slope RT (%)	N/A
N/A	Flare Traversable LT?	N/A	N/A	Flare Traversable RT?	N/A
N/A	Landing Length (in)	N/A	N/A	DWS Provided?	N/A
N/A	Landing Width (in)	N/A	N/A	DWS Contrast?	N/A
N/A	Landing Slope (%)	N/A	N/A	DWS Length (in)	N/A
N/A	Landing X Slope (%)	N/A	N/A	DWS Full Width?	N/A
N/A	Landing Curb? (Y/N)	N/A	N/A	DWS Offset (in)	N/A
N/A	Shared Landing?	N/A			
N/A	Gutter Ponding?	N/A	N/A	Gutter Slope (%)	N/A
N/A	Gutter Lip Ht (in)	N/A	N/A	Gutter X Slope (%)	N/A
N/A	Painted X Walk1?	No	N/A	Painted X Walk2?	N/A
	X Walk 1 Direction	To SW		X Walk 2 Direction	N/A
	X Walk 1 Width (in)	N/A		X Walk 2 Width (in)	N/A
	X Walk 1 Slope (%)	4.4		X Walk 2 Slope (%)	N/A
	X Walk 1 X Slope (%)	2.7		X Walk 2 X Slope (%)	N/A

N/A	Ramp inside XWalk1?	N/A	N/A	Ramp inside XWalk2?	N/A
	Road Slope (%)	2.7		Clear Space?	N/A
	Road X Slope (%)	4.4	N/A	Clear Space to XWalk (in)	N/A
N/A	Any Obstructions?	N/A	N/A	Storm Grate/Utility Hazard?	N/A
	Obstruction Type			Storm Grate/Utility Type	
		N/A			N/A
			Yes	Surface Condition? (G/P)	Good
			No	Curb Slope (%)	10.9

Remove & Replace Curb Ramp With Two New Directional Ramps or Equivalent.

Total Cost: \$ 3200.00
