Access Compliance Report

Public Rights-of-Way

(Curb Ramps)

Intersection ID: 6114	Main Street: ATKINS_RIDGE_DR	Cross Street: HARTLEY_HILLS_DR	Location:	E
ADA ID: 54A11ECAC28B	Ramp Type: Perp	Initial Pass/Fail: Fail	Overall Compliance: No	Severity Score: 37.5
Codes/Mitigation Info/Possible Solution		Field Measurements/Component Compliance

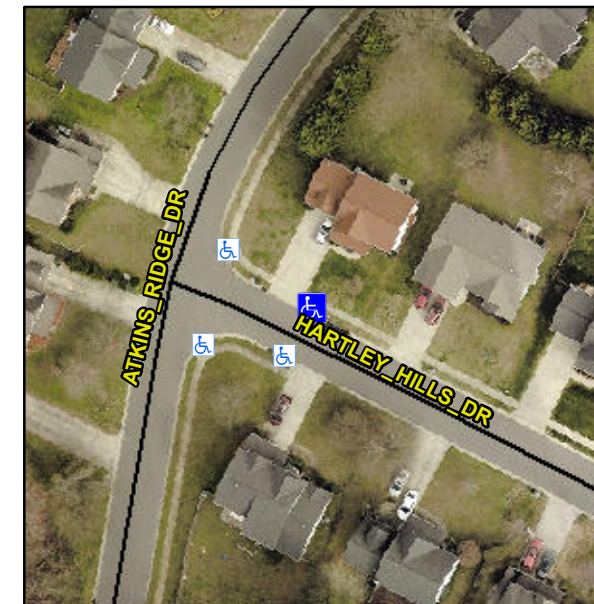
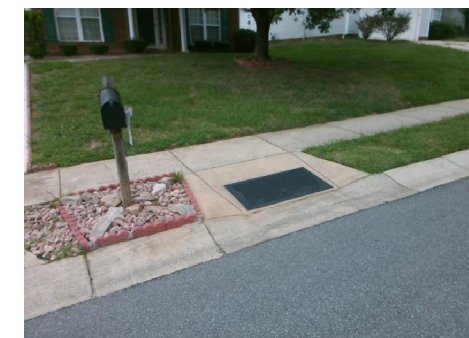
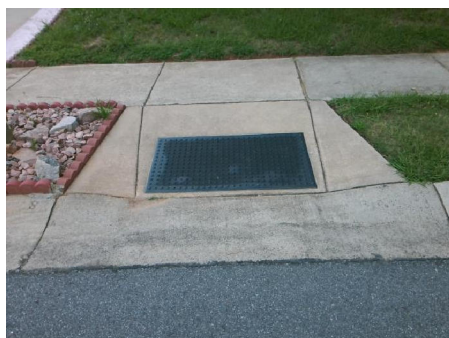
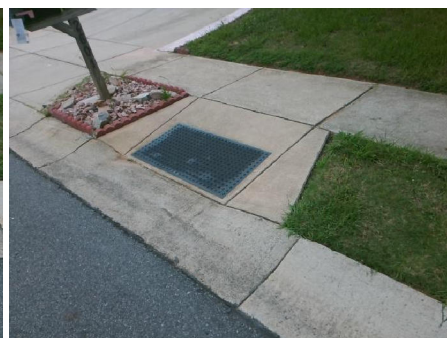
Not Found, R304.2.2, R304.5.3

Compliance	Description	Data	Compliance	Description	Data
N/A	Ramp Length (in)	47.0	No	Ramp Slope (%)	15.4
Yes	Ramp Width (in)	52.0	No	Ramp XSlope (%)	5.6
N/A	Flare Type LT	N/A	N/A	Flare Type RT	N/A
N/A	Flare Slope LT (%)	N/A	N/A	Flare Slope RT (%)	N/A
N/A	Flare Traversable LT?	N/A	N/A	Flare Traversable RT?	N/A
N/A	Landing Length (in)	N/A	N/A	DWS Provided?	N/A
N/A	Landing Width (in)	N/A	N/A	DWS Contrast?	N/A
N/A	Landing Slope (%)	N/A	N/A	DWS Length (in)	N/A
N/A	Landing X Slope (%)	N/A	N/A	DWS Full Width?	N/A
N/A	Landing Curb? (Y/N)	N/A	N/A	DWS Offset (in)	N/A
N/A	Shared Landing?	N/A			
N/A	Gutter Ponding?	N/A	N/A	Gutter Slope (%)	N/A
N/A	Gutter Lip Ht (in)	0.5	N/A	Gutter X Slope (%)	N/A
N/A	Painted X Walk1?	No	N/A	Painted X Walk2?	N/A
	X Walk 1 Direction	To S		X Walk 2 Direction	N/A
N/A	X Walk 1 Width (in)	N/A	N/A	X Walk 2 Width (in)	N/A
	X Walk 1 Slope (%)	8.0		X Walk 2 Slope (%)	N/A
	X Walk 1 X Slope (%)	5.2		X Walk 2 X Slope (%)	N/A

N/A	Ramp inside XWalk1?	N/A	N/A	Ramp inside XWalk2?	N/A
	Road Slope (%)	N/A	N/A	Clear Space?	N/A
	Road X Slope (%)	N/A	N/A	Clear Space to XWalk (in)	N/A
N/A	Any Obstructions?	N/A	N/A	Storm Grate/Utility Hazard?	N/A
	Obstruction Type			Storm Grate/Utility Type	
		N/A			N/A
			Yes	Surface Condition? (G/P)	Good

Possible Solutions:

Remove & Replace Entire Ramp.
