Access Compliance Report

Public Rights-of-Way

(Curb Ramps)

Intersection ID: 32284	Main Street: LANDING_PLACE_LN	Cross Street: STEWARTS_BEND_LN	Location: SE
ADA ID: 54A1B68C0850	Ramp Type: PerpDiag	Initial Pass/Fail: Fail	Overall Compliance: No
		Severity Score: 10

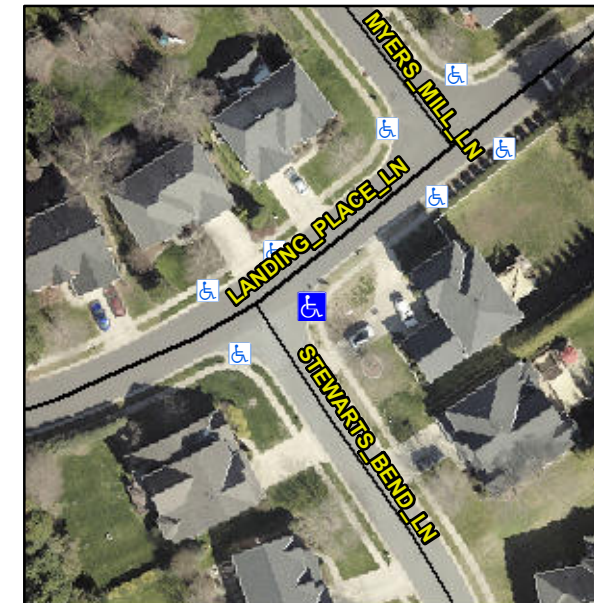
Not Found, R304.5.1, R304.5.3

Compliance	Description	Data	Compliance	Description	Data
N/A	Ramp Length (in)	47.5	Yes	Ramp Slope (%)	7.3
No	Ramp Width (in)	40.0	No	Ramp XSlope (%)	4.9
N/A	Flare Type LT	N/A	N/A	Flare Type RT	N/A
N/A	Flare Slope LT (%)	N/A	N/A	Flare Slope RT (%)	N/A
N/A	Flare Traversable LT?	N/A	N/A	Flare Traversable RT?	N/A
N/A	Landing Length (in)	N/A	N/A	DWS Provided?	N/A
N/A	Landing Width (in)	N/A	N/A	DWS Contrast?	N/A
N/A	Landing Slope (%)	N/A	N/A	DWS Length (in)	N/A
N/A	Landing X Slope (%)	N/A	N/A	DWS Full Width?	N/A
N/A	Landing Curb? (Y/N)	N/A	N/A	DWS Offset (in)	N/A
N/A	Shared Landing?	N/A			
N/A	Gutter Ponding?	N/A	N/A	Gutter Slope (%)	N/A
N/A	Gutter Lip Ht (in)	N/A	N/A	Gutter X Slope (%)	N/A
N/A	Painted X Walk1?	No	N/A	Painted X Walk2?	No
	X Walk 1 Direction	To NW		X Walk 2 Direction	To SW
N/A	X Walk 1 Width (in)	N/A	N/A	X Walk 2 Width (in)	N/A
	X Walk 1 Slope (%)	4.8		X Walk 2 Slope (%)	2.3
	X Walk 1 X Slope (%)	0.5		X Walk 2 X Slope (%)	5.9

N/A	Ramp inside XWalk1?	N/A	N/A	Ramp inside XWalk2?	N/A
	Road Slope (%)	4.3	N/A	Clear Space?	N/A
	Road X Slope (%)	3.5	N/A	Clear Space to XWalk (in)	N/A
N/A	Any Obstructions?	N/A	N/A	Storm Grate/Utility Hazard?	N/A
	Obstruction Type			Storm Grate/Utility Type	
		N/A			N/A
			Yes	Surface Condition? (G/P)	Good

Possible Solutions:

Remove & Replace Curb Ramp With Two New Directional Ramps or Equivalent.
