## **Access Compliance Report Public Rights-of-Way** (Curb Ramps)

Intersection ID: 49656 Main Street: SKYLINE\_VIEW\_WY **Cross Street: SEIGLE POINT DR** Location: Ε ADA ID: 54A582673424 Ramp Type: Perp Initial Pass/Fail: Fail **Overall Compliance: No Severity Score:** 12.5

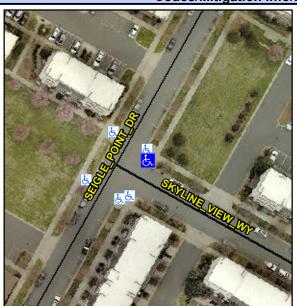
Field Measurements/Component Compliance					
Compliance Description		Data	Comp	liance Description	Data
N/A	Ramp Length (in)	66.0	No	Ramp Slope (%)	8.4
Yes	Ramp Width (in)	76.5	Yes	Ramp XSlope (%)	0.8
N/A	Flare Type LT	N/A	N/A	Flare Type RT	N/A
N/A	Flare Slope LT (%)	N/A	N/A	Flare Slope RT (%)	N/A
N/A	Flare Traversable LT?	N/A	N/A	Flare Traversable RT?	N/A
N/A	Landing Length (in)	N/A	N/A	DWS Provided?	N/A
N/A	Landing Width (in)	N/A	N/A	DWS Contrast?	N/A
N/A	Landing Slope (%)	N/A	N/A	DWS Length (in)	N/A
N/A	Landing X Slope (%)	N/A	N/A	DWS Full Width?	N/A
N/A	Landing Curb? (Y/N)	N/A	N/A	DWS Offset (in)	N/A
N/A	Shared Landing?	N/A			
N/A	Gutter Ponding?	N/A	N/A	Gutter Slope (%)	N/A
N/A	Gutter Lip Ht (in)	N/A	N/A	Gutter X Slope (%)	N/A
N/A	Painted X Walk1?	No	N/A	Painted X Walk2?	N/A
	X Walk 1 Direction	To SW		X Walk 2 Direction	N/A
N/A	X Walk 1 Width (in)	N/A	N/A	X Walk 2 Width (in)	N/A
	X Walk 1 Slope (%)	1.7		X Walk 2 Slope (%)	N/A

**SKYLINE VIEW WY** Street 1 Name Stop Condition-Street 2 StopSign Street 2 Name N/A Stop Condition-Street 1 N/A Possible Solutions: Remove & Replace Entire Ramp. Surveyor Notes: N/A PROW/ADA: R304.2.2
