Access Compliance Report

Public Rights-of-Way

(Curb Ramps)

Intersection ID: 45830	Main Street: EMMA_LYNN_CT	Cross Street: CHRISTENBURY_HILLS_LN	Location: NE
ADA ID: 54B801197B1E	Ramp Type: PerpDiag	Initial Pass/Fail: Fail	Overall Compliance: No
Severity Score: 31.25			
Codes/Mitigation Info/Possible Solution		Field Measurements/Component Compliance

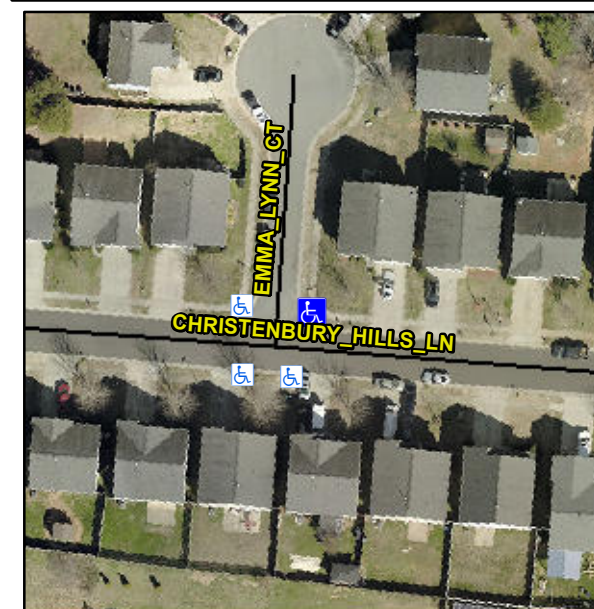
Not Found, R304.5.1, R304.2.2, R304.5.3

Compliance	Description	Data	Compliance	Description	Data
N/A	Ramp Length (in)	48.0	No	Ramp Slope (%)	8.7
No	Ramp Width (in)	35.5	No	Ramp XSlope (%)	4.4
N/A	Flare Type LT	N/A	N/A	Flare Type RT	N/A
N/A	Flare Slope LT (%)	N/A	N/A	Flare Slope RT (%)	N/A
N/A	Flare Traversable LT?	N/A	N/A	Flare Traversable RT?	N/A
N/A	Landing Length (in)	N/A	N/A	DWS Provided?	N/A
N/A	Landing Width (in)	N/A	N/A	DWS Contrast?	N/A
N/A	Landing Slope (%)	N/A	N/A	DWS Length (in)	N/A
N/A	Landing X Slope (%)	N/A	N/A	DWS Full Width?	N/A
N/A	Landing Curb? (Y/N)	N/A	N/A	DWS Offset (in)	N/A
N/A	Shared Landing?	N/A			
N/A	Gutter Ponding?	N/A	N/A	Gutter Slope (%)	N/A
N/A	Gutter Lip Ht (in)	N/A	N/A	Gutter X Slope (%)	N/A
N/A	Painted X Walk1?	No	N/A	Painted X Walk2?	No
	X Walk 1 Direction	To W		X Walk 2 Direction	To S
N/A	X Walk 1 Width (in)	N/A	N/A	X Walk 2 Width (in)	N/A
	X Walk 1 Slope (%)	3.2		X Walk 2 Slope (%)	2.5
	X Walk 1 X Slope (%)	1.7		X Walk 2 X Slope (%)	4.7

N/A	Ramp inside XWalk1?	N/A	N/A	Ramp inside XWalk2?	N/A
	Road Slope (%)	4.6	N/A	Clear Space?	N/A
	Road X Slope (%)	0.9	N/A	Clear Space to XWalk (in)	N/A
N/A	Any Obstructions?	N/A	N/A	Storm Grate/Utility Hazard?	N/A
	Obstruction Type			Storm Grate/Utility Type	
		N/A			N/A
			Yes	Surface Condition? (G/P)	Good

Remove & Replace Curb Ramp With Two New Directional Ramps or Equivalent.
