Access Compliance Report

Public Rights-of-Way

(Curb Ramps)

Intersection ID: 13871	Main Street: E_5TH_ST	Cross Street: HAWTHORNE_LN	Location: E
ADA ID: 54BD2460C42D	Ramp Type: PerpDiag	Initial Pass/Fail: Fail	Overall Compliance: No
Severity Score: 12.5			
Codes/Mitigation Info/Possible Solution		Field Measurements/Component Compliance

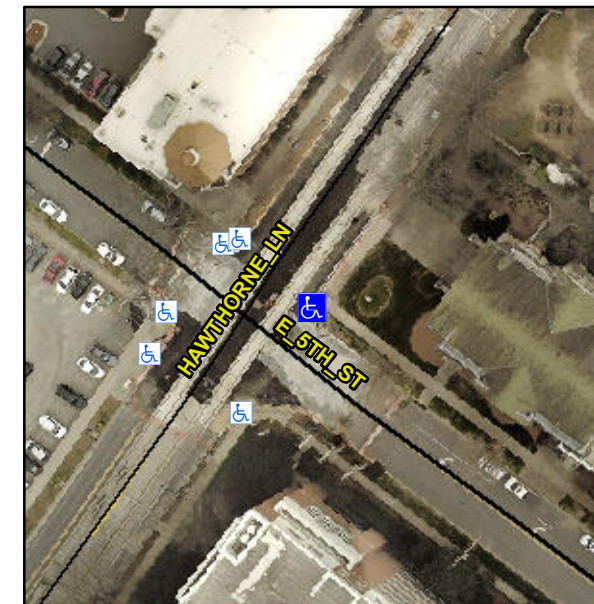
Not Found, R304.2.2

Compliance	Description	Data	Compliance	Description	Data
N/A	Ramp Length (in)	59.0	No	Ramp Slope (%)	8.9
Yes	Ramp Width (in)	48.0	Yes	Ramp XSlope (%)	1.1
N/A	Flare Type LT	N/A	N/A	Flare Type RT	N/A
N/A	Flare Slope LT (%)	N/A	N/A	Flare Slope RT (%)	N/A
N/A	Flare Traversable LT?	N/A	N/A	Flare Traversable RT?	N/A
N/A	Landing Length (in)	N/A	N/A	DWS Provided?	N/A
N/A	Landing Width (in)	N/A	N/A	DWS Contrast?	N/A
N/A	Landing Slope (%)	N/A	N/A	DWS Length (in)	N/A
N/A	Landing X Slope (%)	N/A	N/A	DWS Full Width?	N/A
N/A	Landing Curb? (Y/N)	N/A	N/A	DWS Offset (in)	N/A
N/A	Shared Landing?	N/A			
N/A	Gutter Ponding?	N/A	N/A	Gutter Slope (%)	N/A
N/A	Gutter Lip Ht (in)	N/A	N/A	Gutter X Slope (%)	N/A
N/A	Painted X Walk1?	Yes	N/A	Painted X Walk2?	Yes
	X Walk 1 Direction	To NW		X Walk 2 Direction	To SW
N/A	X Walk 1 Width (in)	139.0	N/A	X Walk 2 Width (in)	112.0
	X Walk 1 Slope (%)	4.9		X Walk 2 Slope (%)	8.5
	X Walk 1 X Slope (%)	3.9		X Walk 2 X Slope (%)	4.2

N/A	Ramp inside XWalk1?	Yes	N/A	Ramp inside XWalk2?	Yes
	Road Slope (%)	0.7	N/A	Clear Space?	N/A
	Road X Slope (%)	9.0	N/A	Clear Space to XWalk (in)	N/A
N/A	Any Obstructions?	N/A	N/A	Storm Grate/Utility Hazard?	N/A
	Obstruction Type			Storm Grate/Utility Type	
		N/A			N/A
		Yes		Surface Condition? (G/P)	Good

Possible Solutions:

Remove & Replace Curb Ramp With Two New Directional Ramps or Equivalent.
