Access Compliance Report

Public Rights-of-Way

(Curb Ramps)

Intersection ID: 48001	Main Street: LARKMEAD_FOREST_DR	Cross Street: CLYMER_CT	Location: SE
ADA ID: 54BEE0DD8353	Ramp Type: Perp	Initial Pass/Fail: Fail	Overall Compliance: No
Codes/Mitigation Info/Possible Solution			Severity Score: 10
			Field Measurements/Component Compliance

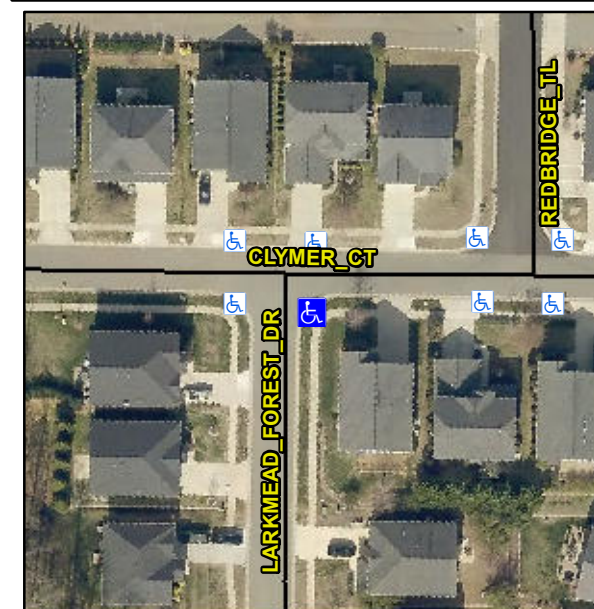
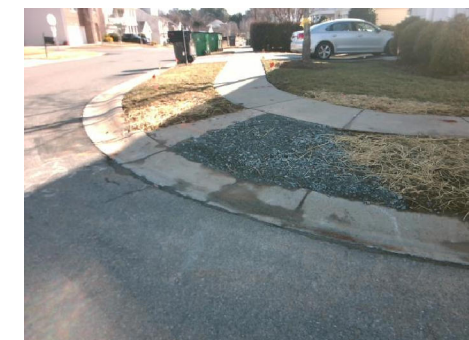
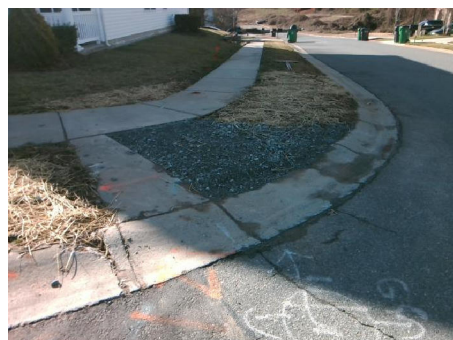
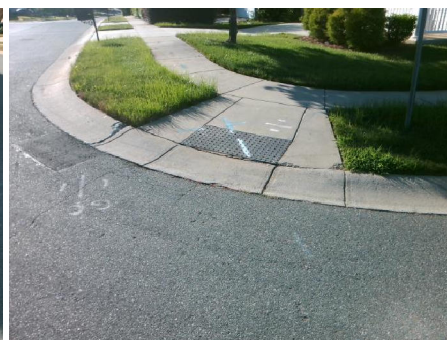
Not Found, R304.5.1, R304.5.3

Compliance	Description	Data	Compliance	Description	Data
N/A	Ramp Length (in)	72.0	Yes	Ramp Slope (%)	6.8
No	Ramp Width (in)	42.5	No	Ramp XSlope (%)	5.0
N/A	Flare Type LT	N/A	N/A	Flare Type RT	N/A
N/A	Flare Slope LT (%)	N/A	N/A	Flare Slope RT (%)	N/A
N/A	Flare Traversable LT?	N/A	N/A	Flare Traversable RT?	N/A
N/A	Landing Length (in)	N/A	N/A	DWS Provided?	N/A
N/A	Landing Width (in)	N/A	N/A	DWS Contrast?	N/A
N/A	Landing Slope (%)	N/A	N/A	DWS Length (in)	N/A
N/A	Landing X Slope (%)	N/A	N/A	DWS Full Width?	N/A
N/A	Landing Curb? (Y/N)	N/A	N/A	DWS Offset (in)	N/A
N/A	Shared Landing?	N/A			
N/A	Gutter Ponding?	N/A	N/A	Gutter Slope (%)	N/A
N/A	Gutter Lip Ht (in)	N/A	N/A	Gutter X Slope (%)	N/A
N/A	Painted X Walk1?	No	N/A	Painted X Walk2?	N/A
	X Walk 1 Direction	To W		X Walk 2 Direction	N/A
N/A	X Walk 1 Width (in)	N/A	N/A	X Walk 2 Width (in)	N/A
	X Walk 1 Slope (%)	0.3		X Walk 2 Slope (%)	N/A
	X Walk 1 X Slope (%)	4.1		X Walk 2 X Slope (%)	N/A

N/A	Ramp inside XWalk1?	N/A	N/A	Ramp inside XWalk2?	N/A
	Road Slope (%)	N/A	N/A	Clear Space?	N/A
	Road X Slope (%)	N/A	N/A	Clear Space to XWalk (in)	N/A
N/A	Any Obstructions?	N/A	N/A	Storm Grate/Utility Hazard?	N/A
	Obstruction Type			Storm Grate/Utility Type	
		N/A			N/A
			Yes	Surface Condition? (G/P)	Good

Remove & Replace Entire Ramp.

Total Cost: \$ 1850.00
