# Access Compliance Report

## Public Rights-of-Way

### (Curb Ramps)

Intersection ID: 30624	Main Street: BRADDOCK_LN	Cross Street: HUMBOLDT_DR	Location: SW
ADA ID: 54CBC79517C7	Ramp Type: PerpDiag	Initial Pass/Fail: Fail	Overall Compliance: No
Severity Score: 22.5			
Codes/Mitigation Info/Possible Solution		Field Measurements/Component Compliance

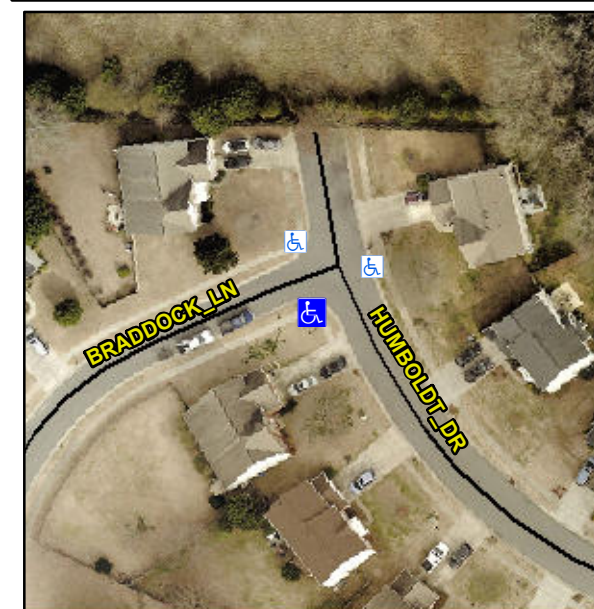
**Not Found, R304.5.1, R304.2.2, R304.5.3**

Compliance	Description	Data	Compliance	Description	Data
N/A	Ramp Length (in)	46.0	No	Ramp Slope (%)	11.8
No	Ramp Width (in)	39.0	No	Ramp XSlope (%)	4.0
N/A	Flare Type LT	N/A	N/A	Flare Type RT	N/A
N/A	Flare Slope LT (%)	N/A	N/A	Flare Slope RT (%)	N/A
N/A	Flare Traversable LT?	N/A	N/A	Flare Traversable RT?	N/A
N/A	Landing Length (in)	N/A	N/A	DWS Provided?	N/A
N/A	Landing Width (in)	N/A	N/A	DWS Contrast?	N/A
N/A	Landing Slope (%)	N/A	N/A	DWS Length (in)	N/A
N/A	Landing X Slope (%)	N/A	N/A	DWS Full Width?	N/A
N/A	Landing Curb? (Y/N)	N/A	N/A	DWS Offset (in)	N/A
N/A	Shared Landing?	N/A			
N/A	Gutter Ponding?	N/A	N/A	Gutter Slope (%)	N/A
N/A	Gutter Lip Ht (in)	N/A	N/A	Gutter X Slope (%)	N/A
N/A	Painted X Walk1?	No	N/A	Painted X Walk2?	No
	X Walk 1 Direction	To E		X Walk 2 Direction	To N
N/A	X Walk 1 Width (in)	N/A	N/A	X Walk 2 Width (in)	N/A
	X Walk 1 Slope (%)	2.8		X Walk 2 Slope (%)	2.1
	X Walk 1 X Slope (%)	1.3		X Walk 2 X Slope (%)	2.6

**Remove & Replace Curb Ramp With Two New Directional Ramps or Equivalent.**
