# Access Compliance Report

## Public Rights-of-Way

### (Curb Ramps)

Intersection ID: 18614	Main Street: HUNTER_LN	Cross Street: RANDOLPH_RD	Location: SW
ADA ID: 54CD45E792B7	Ramp Type: Perp	Initial Pass/Fail: Fail	Overall Compliance: No
Codes/Mitigation Info/Possible Solution		Field Measurements/Component Compliance	
Severity Score: 12.5

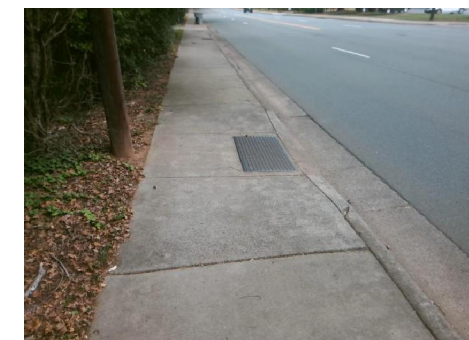
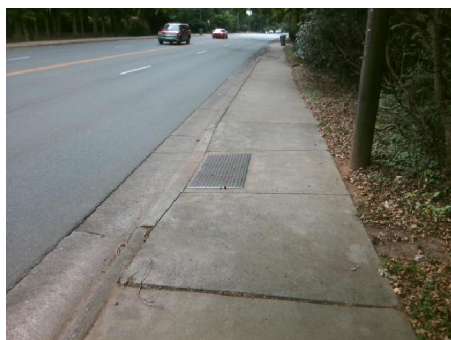
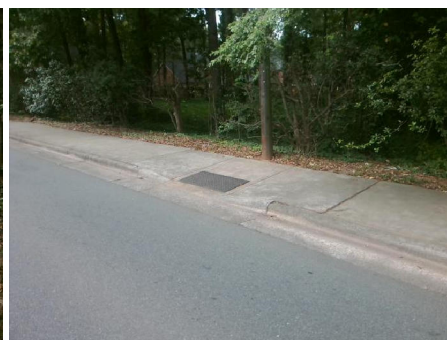
**Not Found, R304.2.2**

Compliance	Description	Data	Compliance	Description	Data
N/A	Ramp Length (in)	71.0	No	Ramp Slope (%)	8.7
Yes	Ramp Width (in)	48.0	Yes	Ramp XSlope (%)	0.1
N/A	Flare Type LT	N/A	N/A	Flare Type RT	N/A
N/A	Flare Slope LT (%)	N/A	N/A	Flare Slope RT (%)	N/A
N/A	Flare Traversable LT?	N/A	N/A	Flare Traversable RT?	N/A
N/A	Landing Length (in)	N/A	N/A	DWS Provided?	N/A
N/A	Landing Width (in)	N/A	N/A	DWS Contrast?	N/A
N/A	Landing Slope (%)	N/A	N/A	DWS Length (in)	N/A
N/A	Landing X Slope (%)	N/A	N/A	DWS Full Width?	N/A
N/A	Landing Curb? (Y/N)	N/A	N/A	DWS Offset (in)	N/A
N/A	Shared Landing?	N/A			
N/A	Gutter Ponding?	N/A	N/A	Gutter Slope (%)	N/A
N/A	Gutter Lip Ht (in)	N/A	N/A	Gutter X Slope (%)	N/A
N/A	Painted X Walk1?	No	N/A	Painted X Walk2?	N/A
	X Walk 1 Direction	To NE		X Walk 2 Direction	N/A
N/A	X Walk 1 Width (in)	N/A	N/A	X Walk 2 Width (in)	N/A
	X Walk 1 Slope (%)	3.1		X Walk 2 Slope (%)	N/A
	X Walk 1 X Slope (%)	0.5		X Walk 2 X Slope (%)	N/A

N/A	Ramp inside XWalk1?	N/A	N/A	Ramp inside XWalk2?	N/A
	Road Slope (%)	N/A	N/A	Clear Space?	N/A
	Road X Slope (%)	N/A	N/A	Clear Space to XWalk (in)	N/A
N/A	Any Obstructions?	N/A	N/A	Storm Grate/Utility Hazard?	N/A
	Obstruction Type			Storm Grate/Utility Type	
		N/A			N/A
			Yes	Surface Condition? (G/P)	Good

Possible Solutions:

**Remove & Replace Entire Ramp.**
