## **Access Compliance Report Public Rights-of-Way** (Curb Ramps)

Intersection ID: 19343 Main Street: ARBOR\_WY Cross Street: USHER\_LN Location: NE **Overall Compliance: No** ADA ID: 54D4097165A9 Ramp Type: PerpDiag Initial Pass/Fail: Fail Severity Score: 33.75

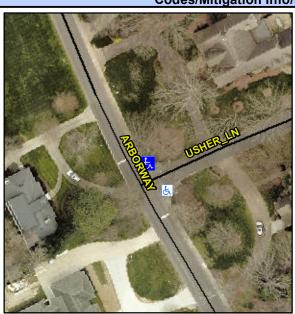
Comp	liance Description	Data	Comp	oliance	Description	Data
N/A	Ramp Length (in)	53.0	No	Ramp	Slope (%)	12.5
No	Ramp Width (in)	40.5	Yes	Ramp	XSlope (%)	1.1
N/A	Flare Type LT	N/A	N/A	Flare	Type RT	N/A
N/A	Flare Slope LT (%)	N/A	N/A	Flare	Slope RT (%)	N/A
N/A	Flare Traversable LT?	N/A	N/A	Flare	Traversable RT?	N/A
N/A	Landing Length (in)	N/A	N/A	DWS	Provided?	N/A
N/A	Landing Width (in)	N/A	N/A	DWS	Contrast?	N/A
N/A	Landing Slope (%)	N/A	N/A	DWS	Length (in)	N/A
N/A	Landing X Slope (%)	N/A	N/A	DWS	Full Width?	N/A
N/A	Landing Curb? (Y/N)	N/A	N/A	DWS	Offset (in)	N/A
N/A	Shared Landing?	N/A				
N/A	Gutter Ponding?	N/A	N/A	Gutte	r Slope (%)	N/A
N/A	Gutter Lip Ht (in)	N/A	N/A	Gutte	r X Slope (%)	N/A
N/A	Painted X Walk1?	No	N/A	Paint	ed X Walk2?	No
	X Walk 1 Direction	To SW		X Wa	lk 2 Direction	To SE
N/A	X Walk 1 Width (in)	N/A	N/A	X Wa	lk 2 Width (in)	N/A
	X Walk 1 Slope (%)	5.1		X Wa	lk 2 Slope (%)	0.8
	X Walk 1 X Slope (%)	1.9		X Wa	lk 2 X Slope (%)	2.8

N/A	Ramp inside XWalk1?	N/A	N/A	Ramp	inside XWalk2?	N/A
	Road Slope (%)	0.9	N/A	Clear	Space?	N/A
	Road X Slope (%)	3.3	N/A	Clear	Space to XWalk (in)	N/A
N/A	Any Obstructions?	N/A	N/A	Storm	n Grate/Utility Hazard?	N/A
	Obstruction Type		l	Storm	n Grate/Utility Type	
		N/A				N/A

Remove & Replace Curb Ramp With **Two New Directional Ramps or** Equivalent.
