Access Compliance Report

Public Rights-of-Way

(Curb Ramps)

| Intersection ID: 2480 | Main Street: CAMBRIDGE_BAY_DR | Cross Street: HEARST_CT | Location: | NW |

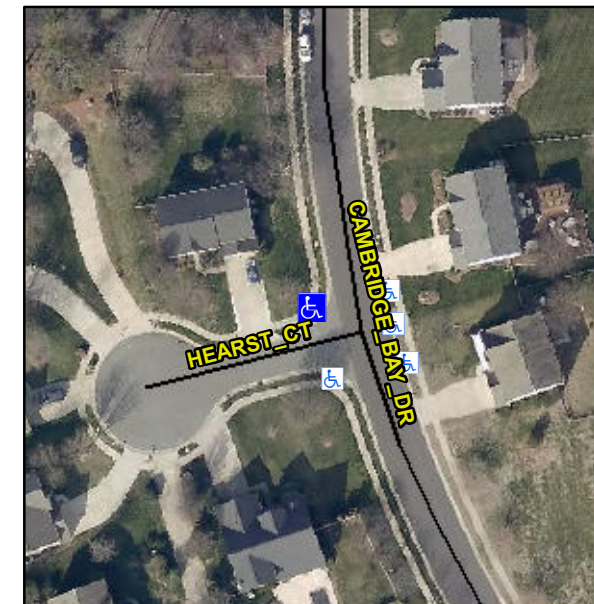
| ADA ID: 54D8C3F89340 | Ramp Type: PerpDiag | Initial Pass/Fail: Fail | Overall Compliance: No | Severity Score: 10 |

| Compliance | Description | Data | Compliance | Description | Data |
|---|---|---|---|---|---|
| N/A | Ramp Length (in) | 47.0 | Yes | Ramp Slope (%) | 7.2 |
| No | Ramp Width (in) | 45.0 | No | Ramp XSlope (%) | 4.4 |

Remove & Replace Curb Ramp With Two New Directional Ramps or Equivalent.

R304.5.1, R304.5.3
