# Access Compliance Report

## Public Rights-of-Way

### (Curb Ramps)

Intersection ID: 10021318	Main Street: BLAKENEY_DR	Cross Street: N/A	Location: NE
ADA ID: 54DB576AFBDE	Ramp Type: BlendTrans1	Initial Pass/Fail: Fail	Overall Compliance: No
		Severity Score: 12.5

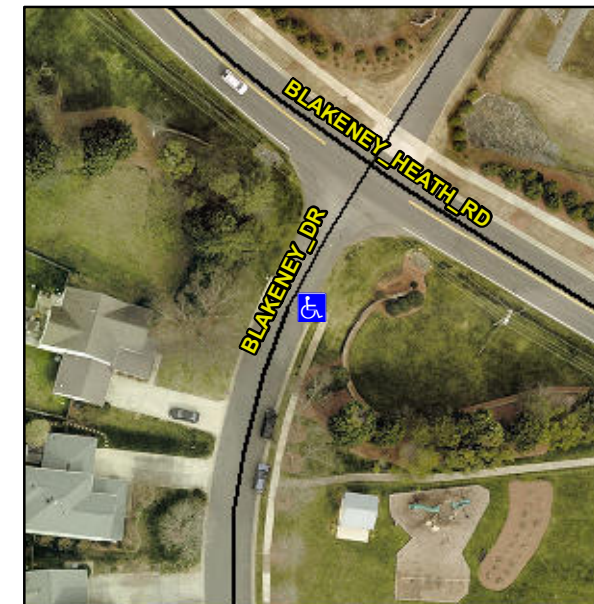
Compliance	Description	Data	Compliance	Description	Data
N/A	Ramp Length (in)	96.0	Yes	BlendTrans Slope (%)	4.4
Yes	Ramp Width (in)	48.0	No	BlendTrans XSlope (%)	5.3
N/A	Flare Type LT	N/A	N/A	Flare Type RT	N/A
N/A	Flare Slope LT (%)	N/A	N/A	Flare Slope RT (%)	N/A
N/A	Flare Traversable LT?	N/A	N/A	Flare Traversable RT?	N/A
N/A	Landing Length (in)	N/A	N/A	DWS Provided?	N/A
N/A	Landing Width (in)	N/A	N/A	DWS Contrast?	N/A
N/A	Landing Slope (%)	N/A	N/A	DWS Length (in)	N/A
N/A	Landing X Slope (%)	N/A	N/A	DWS Full Width?	N/A
N/A	Landing Curb? (Y/N)	N/A	N/A	DWS Offset (in)	N/A
N/A	Shared Landing?	N/A			
N/A	Gutter Ponding?	N/A	N/A	Gutter Slope (%)	N/A
N/A	Gutter Lip Ht (in)	N/A	N/A	Gutter X Slope (%)	N/A
N/A	Painted X Walk1?	No	N/A	Painted X Walk2?	N/A
	X Walk 1 Direction	To SW		X Walk 2 Direction	N/A
	X Walk 1 Width (in)	N/A		X Walk 2 Width (in)	N/A
	X Walk 1 Slope (%)	3.4		X Walk 2 Slope (%)	N/A
	X Walk 1 X Slope (%)	5.4		X Walk 2 X Slope (%)	N/A

N/A	Ramp inside XWalk1?	N/A	N/A	Ramp inside XWalk2?	N/A
	Road Slope (%)	5.4		Clear Space?	N/A
	Road X Slope (%)	3.4	N/A	Clear Space to XWalk (in)	N/A
N/A	Any Obstructions?	N/A	N/A	Storm Grate/Utility Hazard?	N/A
	Obstruction Type			Storm Grate/Utility Type	
		N/A			N/A
			Yes	Surface Condition? (G/P)	Good
			No	Curb Slope (%)	21.6

**Remove & Replace Curb Ramp With Two New Directional Ramps or Equivalent.**

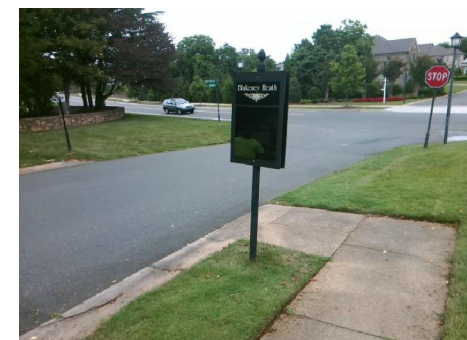
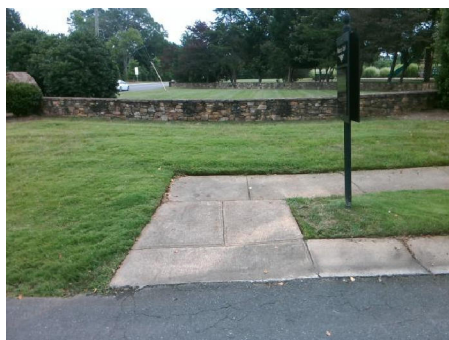
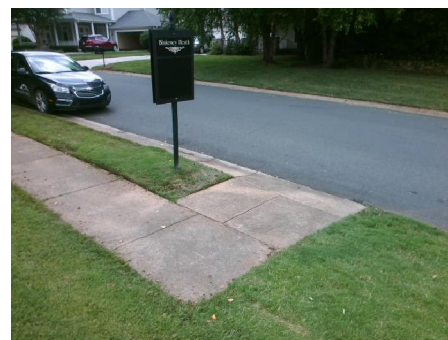
Street 1 Name	BLAKENEY DR
Stop Condition-Street 1	None
Street 2 Name	N/A
Stop Condition-Street 2	N/A
