# Access Compliance Report

## Public Rights-of-Way (Curb Ramps)

| Intersection ID: 17346 | Main Street: DEVON_DR | Cross Street: WILLOW_OAK_RD | Location: | N |
| ADA ID: 54E8F5A420AA | Ramp Type: Directional2 | Initial Pass/Fail: Pass | Overall Compliance: No | Severity Score: 0 |

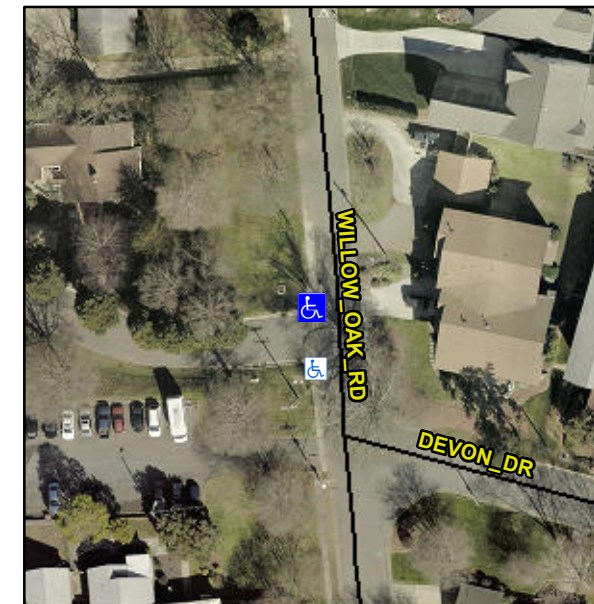
**R304.2.1, R304.5.3**

| Compliance | Description | Data | Compliance | Description | Data |
|---|---|---|---|---|---|
| Yes | Ramp Width (in) | 48.0 | No | Grade Break Slope (%) | 7.0 |
| No | Landing Length (in) | 46.0 | Yes | DWS Provided? | Yes |
| Yes | Landing X Slope (%) | 4.1 | Yes | DWS Full Width? | Yes |

**Remove & Replace Entire Ramp.**
