Access Compliance Report

Public Rights-of-Way (Curb Ramps)

Intersection ID: N/A	Main Street: PROVIDENCE_RD	Cross Street: N/A	Location: N
ADA ID: 54F72727C8C1	Ramp Type: Directional1	Initial Pass/Fail: Fail	Overall Compliance: No
Severity Score: 1.25			
Codes/Mitigation Info/Possible Solution		Field Measurements/Component Compliance

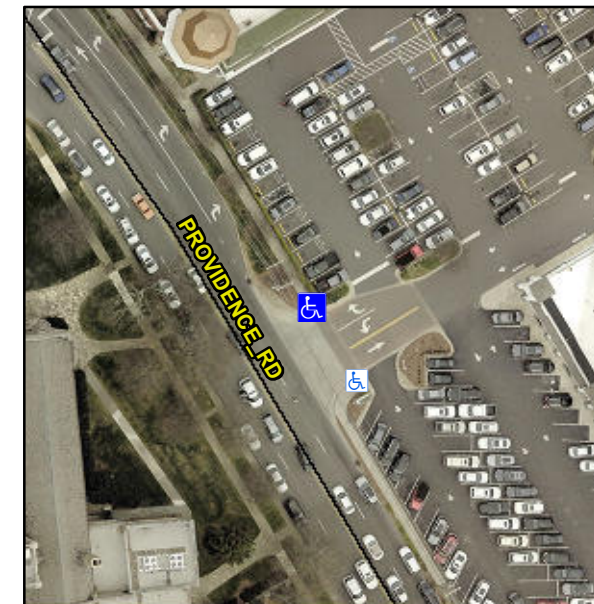
XWALK PAVERS

R304.5.3

Compliance	Description	Data	Compliance	Description	Data
N/A	Ramp Length (in)	90.0	N/A	Grade Break?	N/A
Yes	Ramp Width (in)	72.0	N/A	Grade Break Slope (%)	0.0
Yes	Ramp Slope (%)	1.5	N/A	Grade Break XSlope (%)	0.0
No	Ramp XSlope (%)	2.3			
N/A	Flare Type LT	N/A	N/A	Flare Type RT	N/A
N/A	Flare Slope LT (%)	N/A	N/A	Flare Slope RT (%)	0.0
N/A	Flare Traversable LT?	N/A	N/A	Flare Traversable RT?	N/A
N/A	Landing Length (in)	0.0	N/A	DWS Provided?	N/A
N/A	Landing Width (in)	0.0	N/A	DWS Contrast?	N/A
N/A	Landing Slope (%)	0.0	N/A	DWS Length (in)	N/A
N/A	Landing X Slope (%)	0.0	N/A	DWS Full Width?	N/A
N/A	Landing Curb? (Y/N)	N/A	N/A	DWS Offset LT (in)	N/A
N/A	Shared Landing?	N/A	N/A	DWS Offset RT (in)	N/A
N/A	Gutter Ponding?	0.0	N/A	Gutter Slope (%)	N/A
N/A	Gutter Lip Ht (in)	0.0	N/A	Gutter X Slope (%)	N/A
N/A	Painted X Walk1?	Yes		Road Slope (%)	3.7
	X Walk 1 Direction	To SE		Road X Slope (%)	2.1
	X Walk 1 Width (in)	72.0		Clear Space?	N/A

X Walk 1 Slope (%)	3.7	N/A	Clear Space to XWalk (in)	N/A
	X Walk 1 X Slope (%)	2.1	N/A	Storm Grate/Utility Hazard?	N/A
N/A	Ramp inside XWalk1?	Yes		Storm Grate/Utility Type	
N/A	Any Obstructions?	N/A			N/A
	Obstruction Type		Yes	Surface Condition? (G/P)	Good
			N/A	Curb Slope (%)	3.0

Remove & Replace Entire Ramp.

\$ 1600.00
