Intersection ID: 29169	Main Street: CHIEFTAIN_DR	Cross Street: FIRESTREAK_DR	Location:	SW
ADA ID: 54F91FC4284B	Ramp Type: BlendTrans1	Initial Pass/Fail: Fail	Overall Compliance: No	Severity Score: 8.75

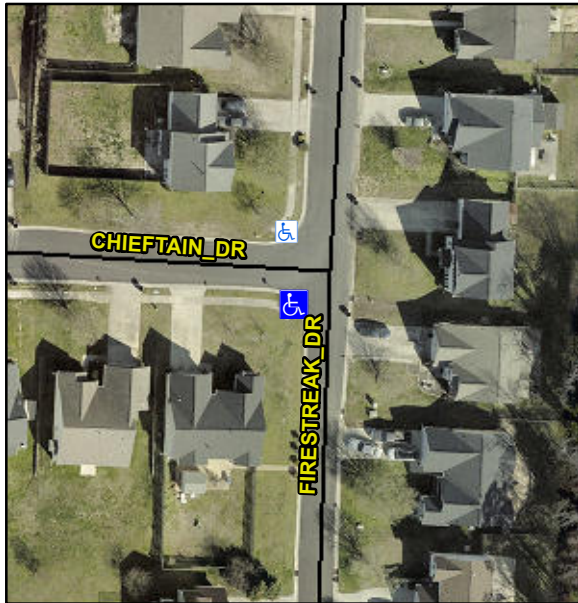
**NO LT SW**

**Not Found, R304.5.1**

Possible Solutions:		Compliance	Description	Data	Compliance	Description	Data
<b>Remove &amp; Replace Curb Ramp With Two New Directional Ramps or Equivalent.</b>	N/A	Ramp Length (in)	44.0	Yes	BlendTrans Slope (%)	3.9	
	No	Ramp Width (in)	47.5	Yes	BlendTrans XSlope (%)	0.5	
	N/A	Flare Type LT	N/A	N/A	Flare Type RT	N/A	
	N/A	Flare Slope LT (%)	N/A	N/A	Flare Slope RT (%)	N/A	
	N/A	Flare Traversable LT?	N/A	N/A	Flare Traversable RT?	N/A	
	N/A	Landing Length (in)	N/A	N/A	DWS Provided?	N/A	
	N/A	Landing Width (in)	N/A	N/A	DWS Contrast?	N/A	
	N/A	Landing Slope (%)	N/A	N/A	DWS Length (in)	N/A	
	N/A	Landing X Slope (%)	N/A	N/A	DWS Full Width?	N/A	
	N/A	Landing Curb? (Y/N)	N/A	N/A	DWS Offset (in)	N/A	
	N/A	Shared Landing?	N/A				
	N/A	Gutter Ponding?	N/A	N/A	Gutter Slope (%)	N/A	
	N/A	Gutter Lip Ht (in)	N/A	N/A	Gutter X Slope (%)	N/A	
	N/A	Painted X Walk1?	No	N/A	Painted X Walk2?	N/A	
Surveyor Notes: <b>NO LT SW</b>		X Walk 1 Direction	To N		X Walk 2 Direction	N/A

X Walk 1 Width (in)	N/A		X Walk 2 Width (in)	N/A	
		X Walk 1 Slope (%)	1.1		X Walk 2 Slope (%)	N/A	
		X Walk 1 X Slope (%)	2.8		X Walk 2 X Slope (%)	N/A	
	N/A	Ramp inside XWalk1?	N/A	N/A	Ramp inside XWalk2?	N/A	
		Road Slope (%)	2.8		Clear Space?	N/A	
		Road X Slope (%)	1.1	N/A	Clear Space to XWalk (in)	N/A	
	N/A	Any Obstructions?	N/A	N/A	Storm Grate/Utility Hazard?	N/A	
		Obstruction Type			Storm Grate/Utility Type		
			N/A			N/A	
				Yes	Surface Condition? (G/P)	Good	
				No	Curb Slope (%)	8.2	
Total Cost:	\$	3200.00

**Remove & Replace Curb Ramp With Two New Directional Ramps or Equivalent.**
