Access Compliance Report

Public Rights-of-Way

(Curb Ramps)

| Intersection ID: 13150 | Main Street: OAKLAND_AV | Cross Street: SUNNYSIDE_AV | Location: NW |

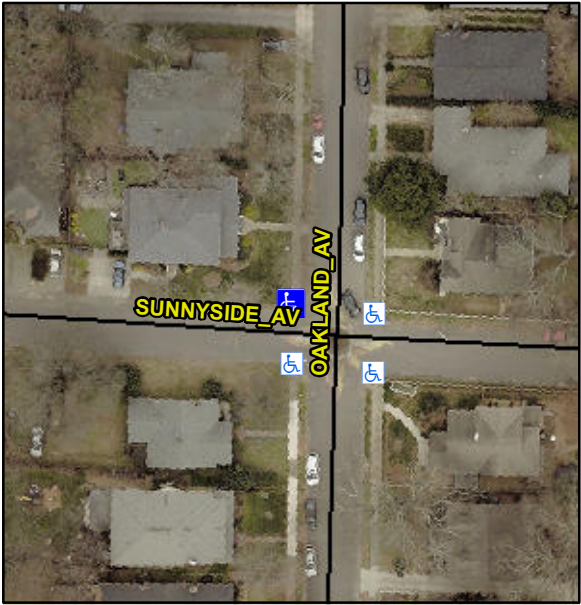
| ADA ID: 54FE8DBA5B31 | Ramp Type: PerpDiag | Initial Pass/Fail: Fail | Overall Compliance: No |

| <p>Surveyor Notes:</p> <p>N/A</p> | | | Yes | Ramp Width (in) | 70.0 | No | Ramp XSlope (%) | 4.7 |
| <p>PROW/ADA:</p> <p>Not Found, R304.5.3</p> | | | N/A | Flare Slope LT (%) | N/A | N/A | Flare Slope RT (%) | N/A |

| | Remove & Replace Curb Ramp With Two New Directional Ramps or Equivalent. | | N/A | Ramp Length (in) | 74.0 | Yes | Ramp Slope (%) | 5.7 |
