Access Compliance Report

Public Rights-of-Way

(Curb Ramps)

Intersection ID: 50729	Main Street: TODDINGTON_LN	Cross Street: ALDERGROVE_RD	Location:	E
ADA ID: 550F7A41AEDE	Ramp Type: PerpDiag	Initial Pass/Fail: Fail	Overall Compliance: No	Severity Score: 10
Codes/Mitigation Info/Possible Solution		Field Measurements/Component Compliance

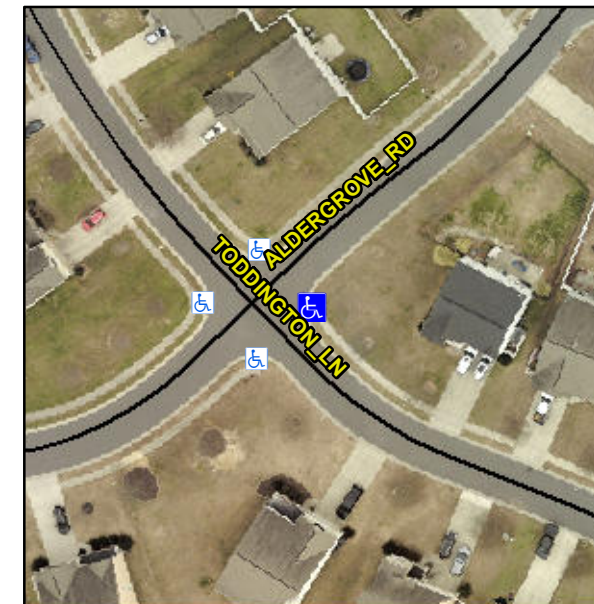
Not Found, R304.5.1, R304.5.3

Compliance	Description	Data	Compliance	Description	Data
N/A	Ramp Length (in)	49.5	Yes	Ramp Slope (%)	8.0
No	Ramp Width (in)	47.0	No	Ramp XSlope (%)	4.6
N/A	Flare Type LT	N/A	N/A	Flare Type RT	N/A
N/A	Flare Slope LT (%)	N/A	N/A	Flare Slope RT (%)	N/A
N/A	Flare Traversable LT?	N/A	N/A	Flare Traversable RT?	N/A
N/A	Landing Length (in)	N/A	N/A	DWS Provided?	N/A
N/A	Landing Width (in)	N/A	N/A	DWS Contrast?	N/A
N/A	Landing Slope (%)	N/A	N/A	DWS Length (in)	N/A
N/A	Landing X Slope (%)	N/A	N/A	DWS Full Width?	N/A
N/A	Landing Curb? (Y/N)	N/A	N/A	DWS Offset (in)	N/A
N/A	Shared Landing?	N/A			
N/A	Gutter Ponding?	N/A	N/A	Gutter Slope (%)	N/A
N/A	Gutter Lip Ht (in)	N/A	N/A	Gutter X Slope (%)	N/A
N/A	Painted X Walk1?	No	N/A	Painted X Walk2?	No
	X Walk 1 Direction	To NW		X Walk 2 Direction	To SW
N/A	X Walk 1 Width (in)	N/A	N/A	X Walk 2 Width (in)	N/A
	X Walk 1 Slope (%)	1.7		X Walk 2 Slope (%)	2.3
	X Walk 1 X Slope (%)	2.5		X Walk 2 X Slope (%)	1.3

N/A	Ramp inside XWalk1?	N/A	N/A	Ramp inside XWalk2?	N/A
	Road Slope (%)	3.5	N/A	Clear Space?	N/A
	Road X Slope (%)	0.4	N/A	Clear Space to XWalk (in)	N/A
N/A	Any Obstructions?	N/A	N/A	Storm Grate/Utility Hazard?	N/A
	Obstruction Type			Storm Grate/Utility Type	
		N/A			N/A
			Yes	Surface Condition? (G/P)	Good

Remove & Replace Curb Ramp With Two New Directional Ramps or Equivalent.
