Access Compliance Report

Public Rights-of-Way

(Curb Ramps)

Intersection ID: 11974	Main Street: N_BREVARD_ST	Cross Street: E_11TH_ST	Location: W
ADA ID: 551A45EABB3B	Ramp Type: PerpDiag	Initial Pass/Fail: Pass	Overall Compliance: No
Severity Score: 0.25			
Codes/Mitigation Info/Possible Solution		Field Measurements/Component Compliance

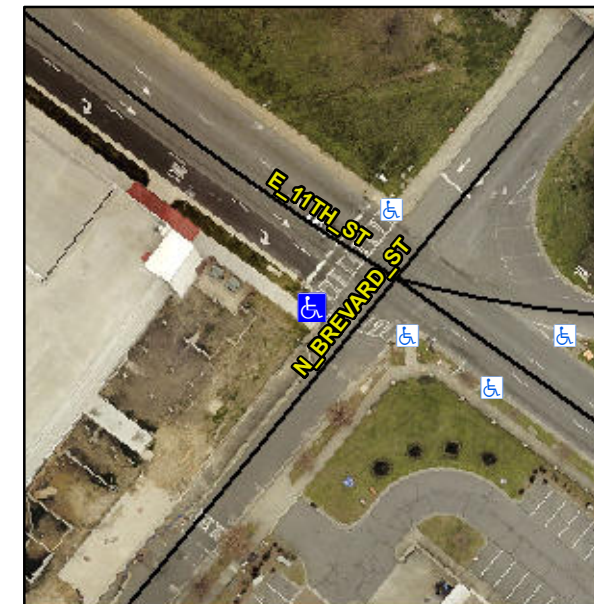
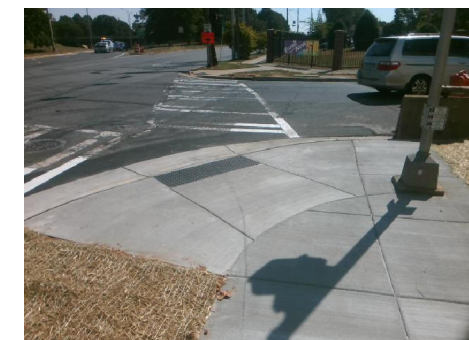
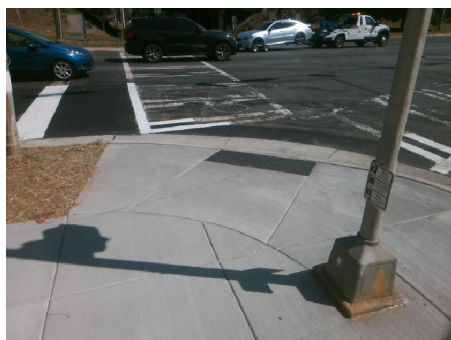
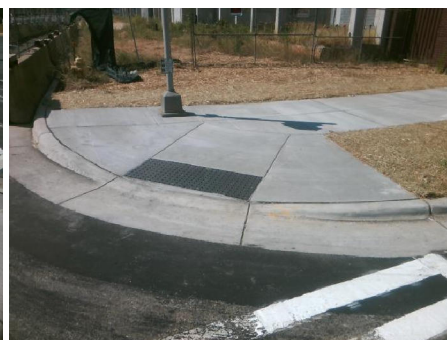
Not Found, R304.5.3, R305.2

Compliance	Description	Data	Compliance	Description	Data
N/A	Ramp Length (in)	86.0	Yes	Ramp Slope (%)	6.5
Yes	Ramp Width (in)	59.0	No	Ramp XSlope (%)	2.2
N/A	Flare Type LT	Sloped	N/A	Flare Type RT	N/A
N/A	Flare Slope LT (%)	6.5	N/A	Flare Slope RT (%)	3.1
N/A	Flare Traversable LT?	Yes	N/A	Flare Traversable RT?	No
Yes	Landing Length (in)	60.0	Yes	DWS Provided?	Yes
Yes	Landing Width (in)	60.0	Yes	DWS Contrast?	Yes
Yes	Landing Slope (%)	0.2	Yes	DWS Length (in)	24.0
Yes	Landing X Slope (%)	2.0	Yes	DWS Full Width?	Yes
N/A	Landing Curb? (Y/N)	No	No	DWS Offset (in)	3.5
N/A	Shared Landing?	No			
Yes	Gutter Ponding?	No	Yes	Gutter Slope (%)	1.0
Yes	Gutter Lip Ht (in)	0.0	Yes	Gutter X Slope (%)	1.8
N/A	Painted X Walk1?	Yes	N/A	Painted X Walk2?	Yes
	X Walk 1 Direction	To SE		X Walk 2 Direction	To NE
N/A	X Walk 1 Width (in)	108.0	N/A	X Walk 2 Width (in)	111.0
	X Walk 1 Slope (%)	3.9		X Walk 2 Slope (%)	0.9
	X Walk 1 X Slope (%)	0.6		X Walk 2 X Slope (%)	1.5

Yes	Ramp inside XWalk1?	Yes	Yes	Ramp inside XWalk2?	Yes
	Road Slope (%)	0.4	N/A	Clear Space?	Yes
	Road X Slope (%)	1.4	Yes	Clear Space to XWalk (in)	72.0
Yes	Any Obstructions?	No	Yes	Storm Grate/Utility Hazard?	No
	Obstruction Type			Storm Grate/Utility Type	
		N/A			N/A
			Yes	Surface Condition? (G/P)	Good

Remove & Replace Curb Ramp With Two New Directional Ramps or Equivalent.
