## **Access Compliance Report Public Rights-of-Way** (Curb Ramps)

Intersection ID: 53044 Main Street: MELODY WOODS CT Cross Street: WILLOW\_OAK\_RD Location: SE ADA ID: 551C5056C8E4 Ramp Type: Perp Initial Pass/Fail: Fail **Overall Compliance: No** Severity Score: 13.75

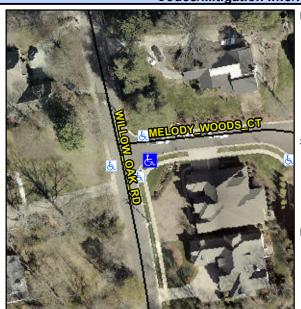
Field Measurements/Component Compliance						
Compliance Description		Data	Comp	liance	Description	Data
N/A	Ramp Length (in)	59.0	No	Ramp	Slope (%)	10.0
Yes	Ramp Width (in)	48.0	No Ramp XSlope (%)		3.7	
N/A	Flare Type LT	N/A	N/A Flare Type RT		N/A	
N/A	Flare Slope LT (%)	N/A	N/A Flare Slope RT (%)		N/A	
N/A	Flare Traversable LT?	N/A	N/A	N/A Flare Traversable RT?		N/A
N/A	Landing Length (in)	N/A	N/A	DWS	Provided?	N/A
N/A	Landing Width (in)	N/A	N/A	DWS	Contrast?	N/A
N/A	Landing Slope (%)	N/A	N/A	DWS	Length (in)	N/A
N/A	Landing X Slope (%)	N/A	N/A	DWS	Full Width?	N/A
N/A	Landing Curb? (Y/N)	N/A	N/A	DWS	Offset (in)	N/A
N/A	Shared Landing?	N/A				
N/A	Gutter Ponding?	N/A	N/A	Gutte	Slope (%)	N/A
N/A	Gutter Lip Ht (in)	1.5	N/A	Gutte	X Slope (%)	N/A
N/A	Painted X Walk1?	No	N/A	Painte	ed X Walk2?	N/A
	X Walk 1 Direction	To N		X Wal	k 2 Direction	N/A
N/A	X Walk 1 Width (in)	N/A	N/A	X Wal	k 2 Width (in)	N/A
	X Walk 1 Slope (%)	0.6		X Wal	k 2 Slope (%)	N/A

X Walk 1 X Slope (%)	1.3		X Wal	k 2 X Slope (%)	N/A
N/A	Ramp inside XWalk1?	N/A	N/A	Ramp	inside XWalk2?	N/A
	Road Slope (%)	N/A	N/A	Clear	Space?	N/A
	Road X Slope (%)	N/A	N/A	Clear	Space to XWalk (in)	N/A
N/A	Any Obstructions?	N/A	N/A	Storm	Grate/Utility Hazard?	N/A
	Obstruction Type			Storm	Grate/Utility Type	
		N/A				N/A
			Yes	Surfac	ce Condition? (G/P)	Good
模

**MELODY WOODS CT** Street 1 Name Stop Condition-Street 2 StopSign Street 2 Name N/A Stop Condition-Street 1 N/A Possible Solutions: Remove & Replace Entire Ramp. Surveyor Notes: N/A PROW/ADA: Not Found, R304.2.2, R304.5.3
