Access Compliance Report

Public Rights-of-Way

(Curb Ramps)

Intersection ID: 53095	Main Street: ALEXANDER_DOWD_DR	Cross Street: DEERFIELD_MANOR_DR	Location:	N
ADA ID: 551F31AEB7BC	Ramp Type: Perp	Initial Pass/Fail: Fail	Overall Compliance: No	Severity Score: 12.5

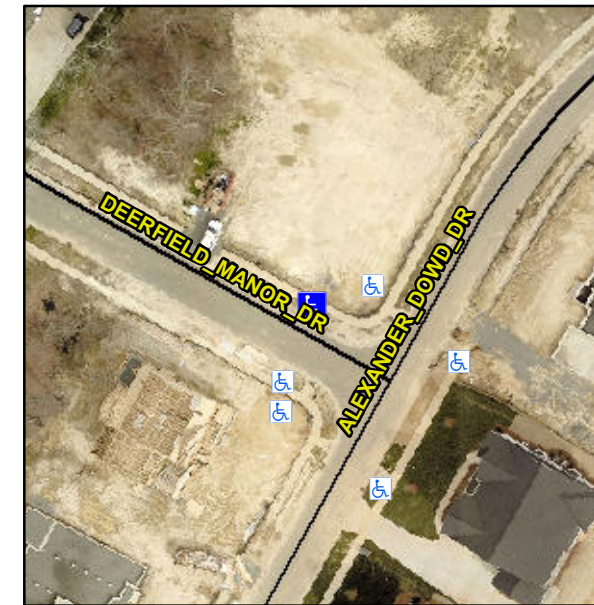
Not Found, R304.5.3

Compliance	Description	Data	Compliance	Description	Data
N/A	Ramp Length (in)	95.0	Yes	Ramp Slope (%)	5.4
Yes	Ramp Width (in)	48.0	No	Ramp XSlope (%)	5.1
N/A	Flare Type LT	N/A	N/A	Flare Type RT	N/A
N/A	Flare Slope LT (%)	N/A	N/A	Flare Slope RT (%)	N/A
N/A	Flare Traversable LT?	N/A	N/A	Flare Traversable RT?	N/A
N/A	Landing Length (in)	N/A	N/A	DWS Provided?	N/A
N/A	Landing Width (in)	N/A	N/A	DWS Contrast?	N/A
N/A	Landing Slope (%)	N/A	N/A	DWS Length (in)	N/A
N/A	Landing X Slope (%)	N/A	N/A	DWS Full Width?	N/A
N/A	Landing Curb? (Y/N)	N/A	N/A	DWS Offset (in)	N/A
N/A	Shared Landing?	N/A			
N/A	Gutter Ponding?	N/A	N/A	Gutter Slope (%)	N/A
N/A	Gutter Lip Ht (in)	N/A	N/A	Gutter X Slope (%)	N/A
N/A	Painted X Walk1?	No	N/A	Painted X Walk2?	N/A
	X Walk 1 Direction	To SW		X Walk 2 Direction	N/A
N/A	X Walk 1 Width (in)	N/A	N/A	X Walk 2 Width (in)	N/A
	X Walk 1 Slope (%)	2.5		X Walk 2 Slope (%)	N/A
	X Walk 1 X Slope (%)	3.3		X Walk 2 X Slope (%)	N/A

Remove & Replace Entire Ramp.
