Intersection ID: 21780	Main Street: SHARON_RD	Cross Street: QUAIL_HOLLOW_RD	Location:	NW
ADA ID: 552A79219290	Ramp Type: PerpDiag	Initial Pass/Fail: Fail	Overall Compliance: No	Severity Score: 13.75

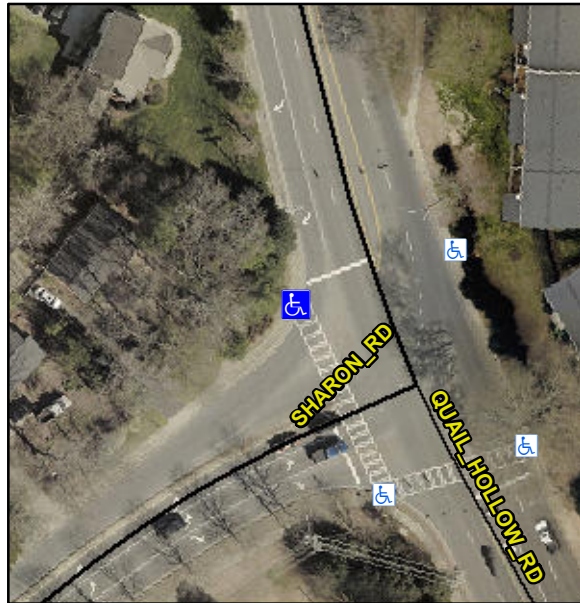
Not Found, R304.2.2

Compliance	Description	Data	Compliance	Description	Data
N/A	Ramp Length (in)	60.0	No	Ramp Slope (%)	10.0
Yes	Ramp Width (in)	48.0	Yes	Ramp XSlope (%)	4.1
N/A	Flare Type LT	N/A	N/A	Flare Type RT	N/A
N/A	Flare Slope LT (%)	N/A	N/A	Flare Slope RT (%)	N/A
N/A	Flare Traversable LT?	N/A	N/A	Flare Traversable RT?	N/A
N/A	Landing Length (in)	N/A	N/A	DWS Provided?	N/A
N/A	Landing Width (in)	N/A	N/A	DWS Contrast?	N/A
N/A	Landing Slope (%)	N/A	N/A	DWS Length (in)	N/A
N/A	Landing X Slope (%)	N/A	N/A	DWS Full Width?	N/A
N/A	Landing Curb? (Y/N)	N/A	N/A	DWS Offset (in)	N/A
N/A	Shared Landing?	N/A			
N/A	Gutter Ponding?	N/A	N/A	Gutter Slope (%)	N/A
N/A	Gutter Lip Ht (in)	N/A	N/A	Gutter X Slope (%)	N/A
N/A	Painted X Walk1?	Yes	N/A	Painted X Walk2?	No
	X Walk 1 Direction	To SE		X Walk 2 Direction	To NE
N/A	X Walk 1 Width (in)	112.0	N/A	X Walk 2 Width (in)	N/A
	X Walk 1 Slope (%)	1.8		X Walk 2 Slope (%)	3.5
	X Walk 1 X Slope (%)	3.4		X Walk 2 X Slope (%)	2.5

N/A	Ramp inside XWalk1?	Yes	N/A	Ramp inside XWalk2?	N/A
	Road Slope (%)	4.1	N/A	Clear Space?	N/A
	Road X Slope (%)	1.6	N/A	Clear Space to XWalk (in)	N/A
N/A	Any Obstructions?	N/A	N/A	Storm Grate/Utility Hazard?	N/A
	Obstruction Type			Storm Grate/Utility Type	
		N/A			N/A
			Yes	Surface Condition? (G/P)	Good

Remove & Replace Curb Ramp With Two New Directional Ramps or Equivalent.
