Access Compliance Report

Public Rights-of-Way

(Curb Ramps)

Intersection ID: 10011809	Main Street: STATESVILLE_RD	Cross Street: N/A	Location: NW
ADA ID: 552F8F0F76D1	Ramp Type: Perp	Initial Pass/Fail: Fail	Overall Compliance: No
			Severity Score: 21.25

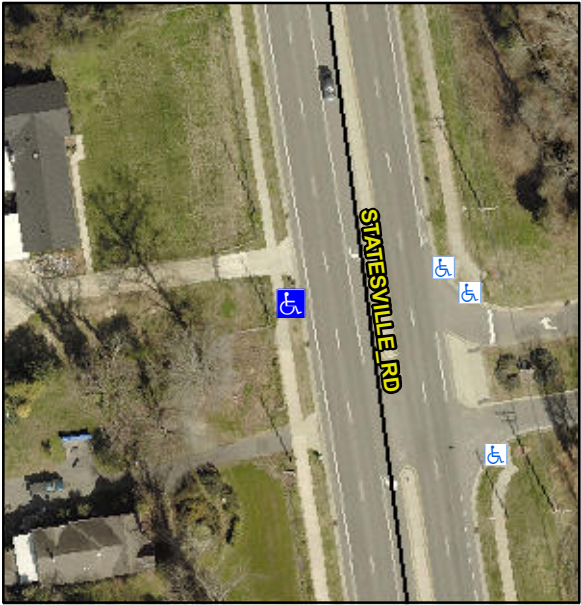
Possible Solutions:		Compliance	Description	Data
	Remove & Replace Entire Ramp.		No	Ramp Length (in)	73.0
			No	Ramp Width (in)	47.5
			N/A	Flare Type LT	N/A
			N/A	Flare Slope LT (%)	N/A
			N/A	Flare Traversable LT?	N/A
			N/A	Landing Length (in)	N/A
			N/A	Landing Width (in)	N/A
			N/A	Landing Slope (%)	N/A
			N/A	Landing X Slope (%)	N/A
			N/A	Landing Curb? (Y/N)	N/A
			N/A	Shared Landing?	N/A
			N/A	Gutter Ponding?	N/A
			N/A	Gutter Lip Ht (in)	N/A
			N/A	Painted X Walk1?	No
				X Walk 1 Direction	To E
			N/A	X Walk 1 Width (in)	N/A
				X Walk 1 Slope (%)	2.4
				X Walk 1 X Slope (%)	0.6
			N/A	Ramp inside XWalk1?	N/A
<p>Surveyor Notes:</p> <p>N/A</p> <p>PROW/ADA:</p> <p>R304.5.1, R304.2.2</p>			N/A	Flare Type RT	N/A
			N/A	Flare Slope RT (%)	N/A
			N/A	Flare Traversable RT?	N/A
			N/A	DWS Provided?	N/A
			N/A	DWS Contrast?	N/A

N/A	DWS Length (in)	N/A
			N/A	DWS Full Width?	N/A
			N/A	DWS Offset (in)	N/A
			N/A	Gutter Slope (%)	N/A
			N/A	Gutter X Slope (%)	N/A
			N/A	Painted X Walk2?	N/A
				X Walk 2 Direction	N/A
			N/A	X Walk 2 Width (in)	N/A
				X Walk 2 Slope (%)	N/A
				X Walk 2 X Slope (%)	N/A
			N/A	Ramp inside XWalk2?	N/A
			N/A	Clear Space?	N/A
			N/A	Clear Space to XWalk (in)	N/A
			N/A	Storm Grate/Utility Hazard?	N/A
				Storm Grate/Utility Type	N/A
<p>Total Cost:</p> <p>\$ 1850.00</p>			N/A	Surface Condition? (G/P)	Good
