# Access Compliance Report

## Public Rights-of-Way

### (Curb Ramps)

| Intersection ID: 29246 | Main Street: LENSWOOD_CT | Cross Street: WOODINGTON_LN | Location: E |

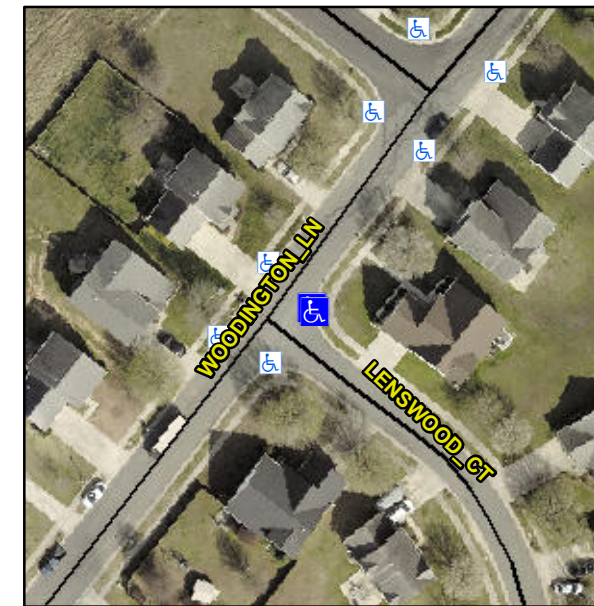
**Not Found, R304.5.1, R304.2.2, R304.5.3**

| Compliance | Description | Data | Compliance | Description | Data |
|---|---|---|---|---|---|
| N/A | Ramp Length (in) | 50.0 | No | Ramp Slope (%) | 10.7 |
| No | Ramp Width (in) | 47.5 | No | Ramp XSlope (%) | 5.6 |

**Remove & Replace Curb Ramp With Two New Directional Ramps or Equivalent.**

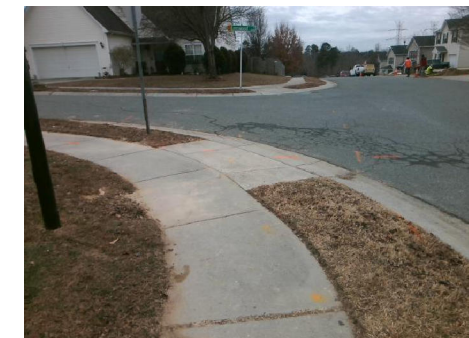
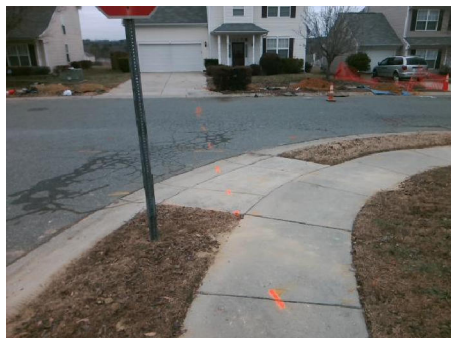
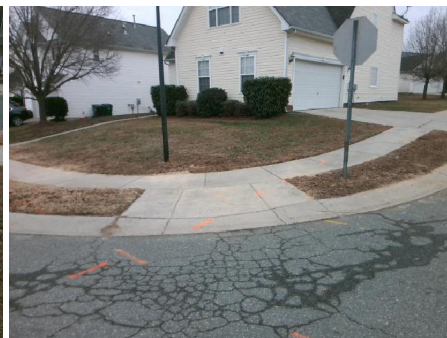
| Compliance | Description | Data | Compliance | Description | Data |
|---|---|---|---|---|---|
| | | | Yes | Surface Condition? (G/P) | Good |
