# Access Compliance Report

## Public Rights-of-Way

### (Curb Ramps)

| Intersection ID: 7779 | Main Street: FRIENDLY_PL | Cross Street: MARCUS_CT | Location: | E |

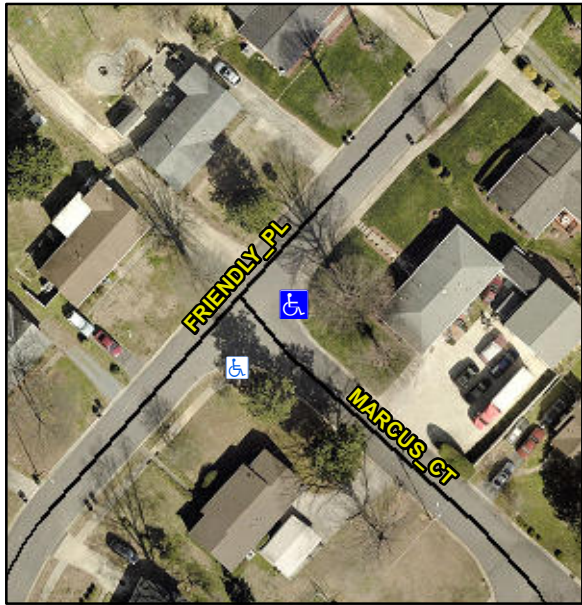
| ADA ID: 5541381822D8 | Ramp Type: BlendTrans2 | Initial Pass/Fail: Fail | Overall Compliance: No | Severity Score: 8.75 |

| Codes/Mitigation Info/Possible Solution | | | Field Measurements/Component Compliance | | | | | |
|---|---|--|---|---|---|---|---|---|
| | | | No | Ramp Width (in) | 43.0 | Yes | BlendTrans XSlope (%) | 0.8 |
| PROW/ADA:<br><br>Not Found, R304.5.1 | | | | Road Slope (%) | 3.1 | | Clear Space? | N/A |
| | | | | | | No | Curb Slope (%) | 15.2 |

| Codes/Mitigation Info/Possible Solution | | | Field Measurements/Component Compliance | | | | | |
|---|---|--|---|---|---|---|---|---|
| | Remove & Replace Curb Ramp With Two New Directional Ramps or Equivalent. | | N/A | Ramp Length (in) | 60.0 | Yes | BlendTrans Slope (%) | 4.1 |
