Access Compliance Report Public Rights-of-Way (Curb Ramps)

Intersection ID: 13988 Main Street: E_5TH_ST **Cross Street: LAMAR AV** Location: Ε ADA ID: 55438C070B4C Ramp Type: BlendTrans1 Initial Pass/Fail: Fail **Overall Compliance: No Severity Score:** 10

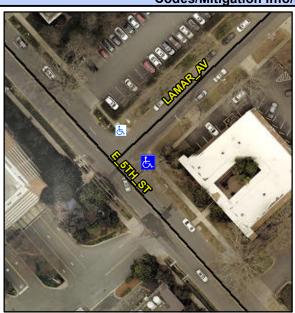
Field Measurements/Component Compliance						
	Compliance Description		Data	Compliance Description		Data
	N/A	Ramp Length (in)	93.0	Yes	BlendTrans Slope (%)	3.0
	No	Ramp Width (in)	46.5	No	BlendTrans XSlope (%)	2.8
	N/A	Flare Type LT	N/A	N/A	Flare Type RT	N/A
	N/A	Flare Slope LT (%)	N/A	N/A	Flare Slope RT (%)	N/A
	N/A	Flare Traversable LT?	N/A	N/A	Flare Traversable RT?	N/A
	N/A	Landing Length (in)	N/A	N/A	DWS Provided?	N/A
	N/A	Landing Width (in)	N/A	N/A	DWS Contrast?	N/A
	N/A	Landing Slope (%)	N/A	N/A	DWS Length (in)	N/A
	N/A	Landing X Slope (%)	N/A	N/A	DWS Full Width?	N/A
	N/A	Landing Curb? (Y/N)	N/A	N/A	DWS Offset (in)	N/A
	N/A	Shared Landing?	N/A			
	N/A	Gutter Ponding?	N/A	N/A	Gutter Slope (%)	N/A
	N/A	Gutter Lip Ht (in)	1.0	N/A	Gutter X Slope (%)	N/A
	N/A	Painted X Walk1?	No	N/A	Painted X Walk2?	No
		X Walk 1 Direction	To NW		X Walk 2 Direction	To SW
		X Walk 1 Width (in)	N/A		X Walk 2 Width (in)	N/A

X Walk 1 Slope (%)	1.4		X Walk 2 Slope (%)	2.7
		X Walk 1 X Slope (%)	2.3		X Walk 2 X Slope (%)	4.8
	N/A	Ramp inside XWalk1?	N/A	N/A	Ramp inside XWalk2?	N/A
		Road Slope (%)	2.8		Clear Space?	N/A
		Road X Slope (%)	5.0	N/A	Clear Space to XWalk (in)	N/A
	N/A	Any Obstructions?	N/A	N/A	Storm Grate/Utility Hazard?	N/A
		Obstruction Type			Storm Grate/Utility Type	
			N/A			N/A
				Yes	Surface Condition? (G/P)	Good
	1			N/A	Curb Slope (%)	4.3

Possible Solutions: Remove & Replace Curb Ramp With **Two New Directional Ramps or** Equivalent.

R304.5.1, R304.5.3
