## Access Compliance Report Public Rights-of-Way (Curb Ramps)

Intersection ID: 10485 Main Street: ANDERSON\_ST Cross Street: THE\_PLAZA Location: N

ADA ID: 5549105F5B80 Ramp Type: Perp Initial Pass/Fail: Fail Overall Compliance: No Severity Score: 17.5

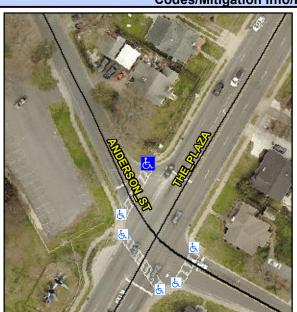
Not Found, R304.5.1

Field Measurements/Component Compliance							
	Comp	liance Description	Data	Comp	liance	Description	Data
	N/A	Ramp Length (in)	37.0	Yes	Ramp	Slope (%)	6.8
	No	Ramp Width (in)	35.0	Yes	Ramp	XSlope (%)	0.8
	N/A	Flare Type LT	N/A	N/A	Flare	Type RT	N/A
	N/A	Flare Slope LT (%)	N/A	N/A	Flare	Slope RT (%)	N/A
	N/A	Flare Traversable LT?	N/A	N/A	Flare <sup>-</sup>	Traversable RT?	N/A
	N/A	Landing Length (in)	N/A	N/A	DWS	Provided?	N/A
	N/A	Landing Width (in)	N/A	N/A	DWS	Contrast?	N/A
	N/A	Landing Slope (%)	N/A	N/A	DWS	Length (in)	N/A
	N/A	Landing X Slope (%)	N/A	N/A	DWS	Full Width?	N/A
	N/A	Landing Curb? (Y/N)	N/A	N/A	DWS	Offset (in)	N/A
	N/A	Shared Landing?	N/A				
	N/A	Gutter Ponding?	N/A	N/A	Gutter	Slope (%)	N/A
	N/A	Gutter Lip Ht (in)	N/A	N/A	Gutter	X Slope (%)	N/A
	N/A	Painted X Walk1?	Yes	N/A	Painte	ed X Walk2?	N/A
		X Walk 1 Direction	To SW		X Wal	k 2 Direction	N/A
	N/A	X Walk 1 Width (in)	115.0	N/A	X Wal	k 2 Width (in)	N/A

Remove & Replace Entire Ramp.

Total Cost: \$ 1850.00
