Access Compliance Report

Public Rights-of-Way

(Curb Ramps)

Intersection ID: 43159	Main Street: ARCHING_OAK_LN	Cross Street: N SHARON AMITY RD	Location: E
ADA ID: 554952227910	Ramp Type: PerpDiag	Initial Pass/Fail: Fail	Overall Compliance: No
Codes/Mitigation Info/Possible Solution		Field Measurements/Component Compliance	
Severity Score: 18.75

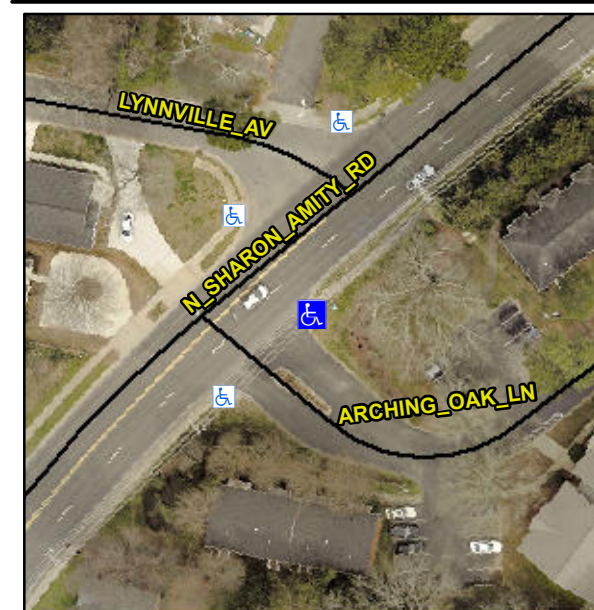
Not Found, R304.5.1, R304.5.3

Compliance	Description	Data	Compliance	Description	Data
N/A	Ramp Length (in)	79.0	Yes	Ramp Slope (%)	5.3
No	Ramp Width (in)	33.0	No	Ramp XSlope (%)	2.3
N/A	Flare Type LT	N/A	N/A	Flare Type RT	N/A
N/A	Flare Slope LT (%)	N/A	N/A	Flare Slope RT (%)	N/A
N/A	Flare Traversable LT?	N/A	N/A	Flare Traversable RT?	N/A
N/A	Landing Length (in)	N/A	N/A	DWS Provided?	N/A
N/A	Landing Width (in)	N/A	N/A	DWS Contrast?	N/A
N/A	Landing Slope (%)	N/A	N/A	DWS Length (in)	N/A
N/A	Landing X Slope (%)	N/A	N/A	DWS Full Width?	N/A
N/A	Landing Curb? (Y/N)	N/A	N/A	DWS Offset (in)	N/A
N/A	Shared Landing?	N/A			
N/A	Gutter Ponding?	N/A	N/A	Gutter Slope (%)	N/A
N/A	Gutter Lip Ht (in)	N/A	N/A	Gutter X Slope (%)	N/A
N/A	Painted X Walk1?	No	N/A	Painted X Walk2?	No
	X Walk 1 Direction	To NW		X Walk 2 Direction	To SW
N/A	X Walk 1 Width (in)	N/A	N/A	X Walk 2 Width (in)	N/A
	X Walk 1 Slope (%)	0.9		X Walk 2 Slope (%)	0.6
	X Walk 1 X Slope (%)	1.2		X Walk 2 X Slope (%)	1.7

N/A	Ramp inside XWalk1?	N/A	N/A	Ramp inside XWalk2?	N/A
	Road Slope (%)	1.4	N/A	Clear Space?	N/A
	Road X Slope (%)	0.8	N/A	Clear Space to XWalk (in)	N/A
N/A	Any Obstructions?	N/A	N/A	Storm Grate/Utility Hazard?	N/A
	Obstruction Type			Storm Grate/Utility Type	
		N/A			N/A
			Yes	Surface Condition? (G/P)	Good

Remove & Replace Curb Ramp With Two New Directional Ramps or Equivalent.
