# Access Compliance Report

## Public Rights-of-Way

### (Curb Ramps)

Intersection ID: 51473	Main Street: LILLIESLEAF_GLENN_LN	Cross Street: TAMARRON_DR	Location:	N
ADA ID: 554B80BF99D2	Ramp Type: PerpDiag	Initial Pass/Fail: Fail	Overall Compliance: No	Severity Score: 8.75

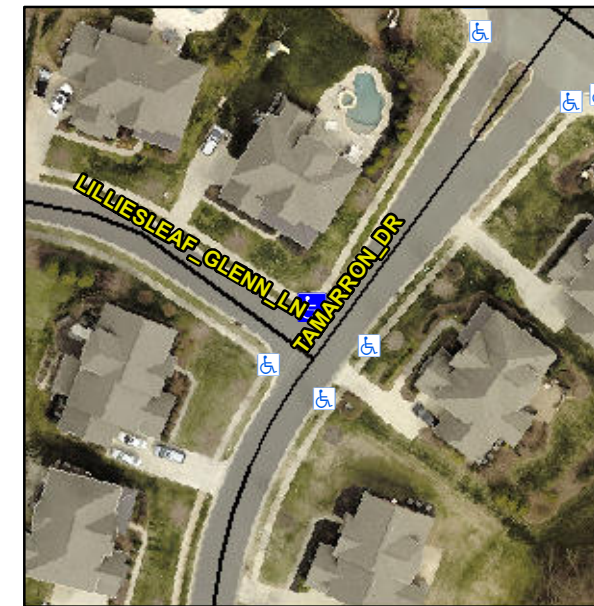
**Not Found, R304.5.1**

Compliance	Description	Data	Compliance	Description	Data
N/A	Ramp Length (in)	51.0	Yes	Ramp Slope (%)	5.0
No	Ramp Width (in)	47.0	Yes	Ramp XSlope (%)	1.2
N/A	Flare Type LT	N/A	N/A	Flare Type RT	N/A
N/A	Flare Slope LT (%)	N/A	N/A	Flare Slope RT (%)	N/A
N/A	Flare Traversable LT?	N/A	N/A	Flare Traversable RT?	N/A
N/A	Landing Length (in)	N/A	N/A	DWS Provided?	N/A
N/A	Landing Width (in)	N/A	N/A	DWS Contrast?	N/A
N/A	Landing Slope (%)	N/A	N/A	DWS Length (in)	N/A
N/A	Landing X Slope (%)	N/A	N/A	DWS Full Width?	N/A
N/A	Landing Curb? (Y/N)	N/A	N/A	DWS Offset (in)	N/A
N/A	Shared Landing?	N/A			
N/A	Gutter Ponding?	N/A	N/A	Gutter Slope (%)	N/A
N/A	Gutter Lip Ht (in)	N/A	N/A	Gutter X Slope (%)	N/A
N/A	Painted X Walk1?	No	N/A	Painted X Walk2?	No
	X Walk 1 Direction	To SW		X Walk 2 Direction	To SE
N/A	X Walk 1 Width (in)	N/A	N/A	X Walk 2 Width (in)	N/A
	X Walk 1 Slope (%)	0.4		X Walk 2 Slope (%)	2.2
	X Walk 1 X Slope (%)	2.6		X Walk 2 X Slope (%)	1.1

N/A	Ramp inside XWalk1?	N/A	N/A	Ramp inside XWalk2?	N/A
	Road Slope (%)	2.1	N/A	Clear Space?	N/A
	Road X Slope (%)	1.2	N/A	Clear Space to XWalk (in)	N/A
N/A	Any Obstructions?	N/A	N/A	Storm Grate/Utility Hazard?	N/A
	Obstruction Type			Storm Grate/Utility Type	
		N/A			N/A
			Yes	Surface Condition? (G/P)	Good

**Remove & Replace Curb Ramp With Two New Directional Ramps or Equivalent.**
