Access Compliance Report

Public Rights-of-Way

(Curb Ramps)

Intersection ID: 12279	Main Street: S_MINT_ST	Cross Street: W_MARTIN_LUTHER_KING_JR_BV	Location: N
ADA ID: 556D3B125267	Ramp Type: Perp	Initial Pass/Fail: Fail	Overall Compliance: No
Severity Score: 21.25			
Codes/Mitigation Info/Possible Solution		Field Measurements/Component Compliance

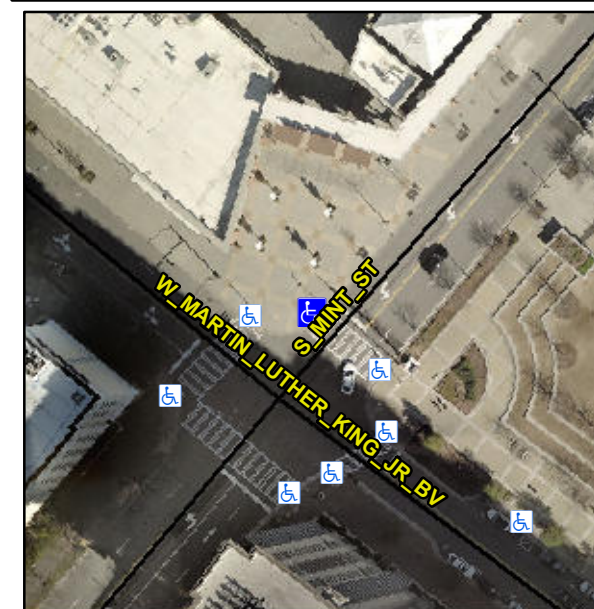
R304.5.1, R304.2.2

Compliance	Description	Data	Compliance	Description	Data
N/A	Ramp Length (in)	78.0	No	Ramp Slope (%)	9.0
No	Ramp Width (in)	47.0	Yes	Ramp XSlope (%)	0.9
N/A	Flare Type LT	N/A	N/A	Flare Type RT	N/A
N/A	Flare Slope LT (%)	N/A	N/A	Flare Slope RT (%)	N/A
N/A	Flare Traversable LT?	N/A	N/A	Flare Traversable RT?	N/A
N/A	Landing Length (in)	N/A	N/A	DWS Provided?	N/A
N/A	Landing Width (in)	N/A	N/A	DWS Contrast?	N/A
N/A	Landing Slope (%)	N/A	N/A	DWS Length (in)	N/A
N/A	Landing X Slope (%)	N/A	N/A	DWS Full Width?	N/A
N/A	Landing Curb? (Y/N)	N/A	N/A	DWS Offset (in)	N/A
N/A	Shared Landing?	N/A			
N/A	Gutter Ponding?	N/A	N/A	Gutter Slope (%)	N/A
N/A	Gutter Lip Ht (in)	N/A	N/A	Gutter X Slope (%)	N/A
N/A	Painted X Walk1?	Yes	N/A	Painted X Walk2?	N/A
	X Walk 1 Direction	To SE		X Walk 2 Direction	N/A
N/A	X Walk 1 Width (in)	171.0	N/A	X Walk 2 Width (in)	N/A
	X Walk 1 Slope (%)	1.0		X Walk 2 Slope (%)	N/A
	X Walk 1 X Slope (%)	1.2		X Walk 2 X Slope (%)	N/A

N/A	Ramp inside XWalk1?	Yes	N/A	Ramp inside XWalk2?	N/A
	Road Slope (%)	N/A	N/A	Clear Space?	N/A
	Road X Slope (%)	N/A	N/A	Clear Space to XWalk (in)	N/A
N/A	Any Obstructions?	N/A	N/A	Storm Grate/Utility Hazard?	N/A
	Obstruction Type			Storm Grate/Utility Type	
		N/A			N/A
		Yes		Surface Condition? (G/P)	Good

Remove & Replace Entire Ramp.

Total Cost: \$ 1850.00
