## **Access Compliance Report Public Rights-of-Way** (Curb Ramps)

Intersection ID: 29824 Main Street: MARVIN RD **Cross Street: WILKLEE DR** Location: N Initial Pass/Fail: Fail **Overall Compliance: No Severity Score:** 12.5 ADA ID: 55712730E899 Ramp Type: PerpDiag

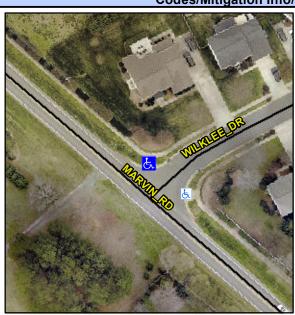
No N/A Ramp Length (in) 110.0 Ramp Slope (%) Yes Ramp XSlope (%) Yes Ramp Width (in) 61.0 N/A N/A Flare Type LT N/A Flare Type RT N/A N/A N/A Flare Slope RT (%) Flare Slope LT (%) N/A Flare Traversable LT? N/A N/A Flare Traversable RT? N/A N/A N/A **DWS Provided?** Landing Length (in) N/A Landing Width (in) N/A N/A **DWS Contrast?** N/A N/A N/A Landing Slope (%) DWS Length (in) N/A Landing X Slope (%) N/A N/A DWS Full Width? N/A Landing Curb? (Y/N) N/A N/A DWS Offset (in) N/A N/A Shared Landing? N/A **Gutter Ponding?** N/A N/A Gutter Slope (%) N/A Gutter Lip Ht (in) N/A N/A Gutter X Slope (%) N/A Painted X Walk1? No N/A Painted X Walk2? X Walk 1 Direction To SW X Walk 2 Direction To SE N/A N/A X Walk 1 Width (in) X Walk 2 Width (in) X Walk 1 Slope (%) 2.3 X Walk 2 Slope (%) X Walk 1 X Slope (%) 2.4 X Walk 2 X Slope (%) N/A N/A N/A Ramp inside XWalk2? Ramp inside XWalk1? Road Slope (%) 4.1 N/A Clear Space? N/A Road X Slope (%) 0.9 Clear Space to XWalk (in) N/A N/A N/A Any Obstructions? Storm Grate/Utility Hazard? **Obstruction Type** Storm Grate/Utility Type

**MARVIN RD** None **WILKLEE DR**  Remove & Replace Curb Ramp With Two New Directional Ramps or Equivalent.

R304.2.2
