Access Compliance Report

Public Rights-of-Way

(Curb Ramps)

| Intersection ID: 48161 | Main Street: HEWITT_ASSOCIATES_DR | Cross Street: IBM_DR | Location: | N |

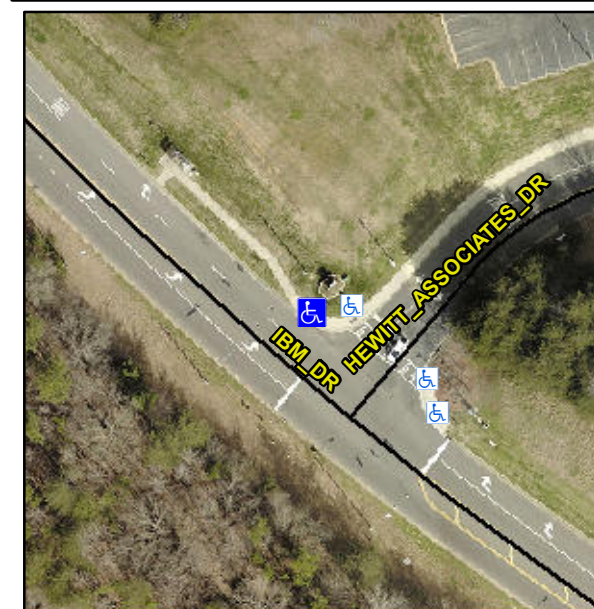
| ADA ID: 5576117E2189 | Ramp Type: Perp | Initial Pass/Fail: Fail | Overall Compliance: No | Severity Score: 8.75 |

N/A

Not Found, R304.5.1

| Compliance | Description | Data | Compliance | Description | Data |
|---|---|---|---|---|---|
| N/A | Ramp Length (in) | 59.0 | Yes | Ramp Slope (%) | 5.2 |
| No | Ramp Width (in) | 47.0 | Yes | Ramp XSlope (%) | 1.8 |

Remove & Replace Entire Ramp.

Total Cost: \$ 1850.00
