Access Compliance Report

Public Rights-of-Way (Curb Ramps)

Intersection ID: 29956	Main Street: NEW_HOUSE_DR	Cross Street: ROYAL_BLUFF_DR	Location: NW
ADA ID: 5577B52E247D	Ramp Type: PerpDiag	Initial Pass/Fail: Fail	Overall Compliance: No Severity Score: 21.25

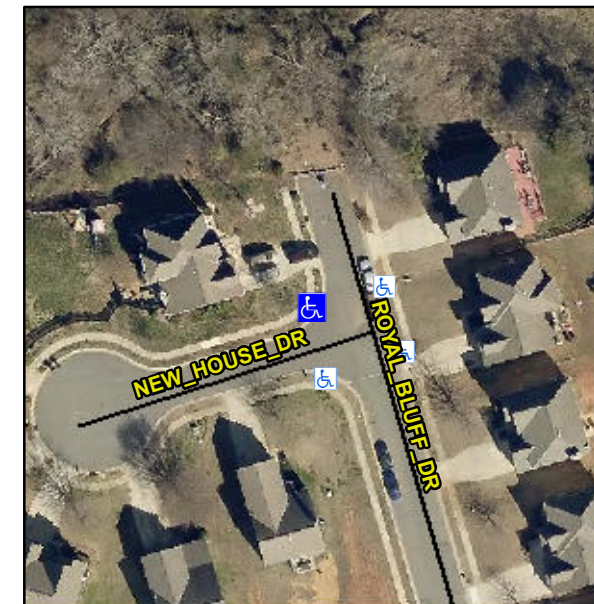
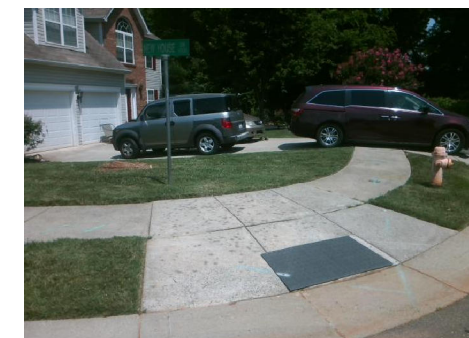
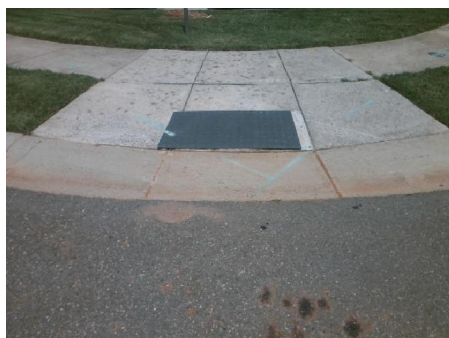
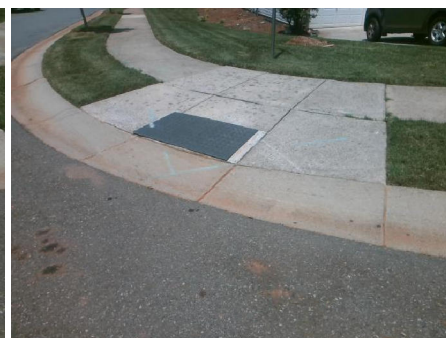
Compliance	Description	Data	Compliance	Description	Data
N/A	Ramp Length (in)	47.5	No	Ramp Slope (%)	9.5
No	Ramp Width (in)	41.0	Yes	Ramp XSlope (%)	0.9
N/A	Flare Type LT	N/A	N/A	Flare Type RT	N/A
N/A	Flare Slope LT (%)	N/A	N/A	Flare Slope RT (%)	N/A
N/A	Flare Traversable LT?	N/A	N/A	Flare Traversable RT?	N/A
N/A	Landing Length (in)	N/A	N/A	DWS Provided?	N/A
N/A	Landing Width (in)	N/A	N/A	DWS Contrast?	N/A
N/A	Landing Slope (%)	N/A	N/A	DWS Length (in)	N/A
N/A	Landing X Slope (%)	N/A	N/A	DWS Full Width?	N/A
N/A	Landing Curb? (Y/N)	N/A	N/A	DWS Offset (in)	N/A
N/A	Shared Landing?	N/A			
N/A	Gutter Ponding?	N/A	N/A	Gutter Slope (%)	N/A
N/A	Gutter Lip Ht (in)	N/A	N/A	Gutter X Slope (%)	N/A
N/A	Painted X Walk1?	No	N/A	Painted X Walk2?	No
	X Walk 1 Direction	To S		X Walk 2 Direction	To E
N/A	X Walk 1 Width (in)	N/A	N/A	X Walk 2 Width (in)	N/A
	X Walk 1 Slope (%)	3.0		X Walk 2 Slope (%)	4.0
	X Walk 1 X Slope (%)	4.8		X Walk 2 X Slope (%)	1.9

N/A	Ramp inside XWalk1?	N/A	N/A	Ramp inside XWalk2?	N/A
	Road Slope (%)	2.0	N/A	Clear Space?	N/A
	Road X Slope (%)	5.4	N/A	Clear Space to XWalk (in)	N/A
N/A	Any Obstructions?	N/A	N/A	Storm Grate/Utility Hazard?	N/A
	Obstruction Type			Storm Grate/Utility Type	
		N/A			N/A
			Yes	Surface Condition? (G/P)	Good

Remove & Replace Curb Ramp With Two New Directional Ramps or Equivalent.
