# Access Compliance Report

## Public Rights-of-Way

| Intersection ID: 30136 | Main Street: GALESBURG_ST | Cross Street: SIDELL_LN | Location: SW |
| ADA ID: 5581611C2FC4 | Ramp Type: BlendTrans1 | Initial Pass/Fail: Pass | Overall Compliance: No |

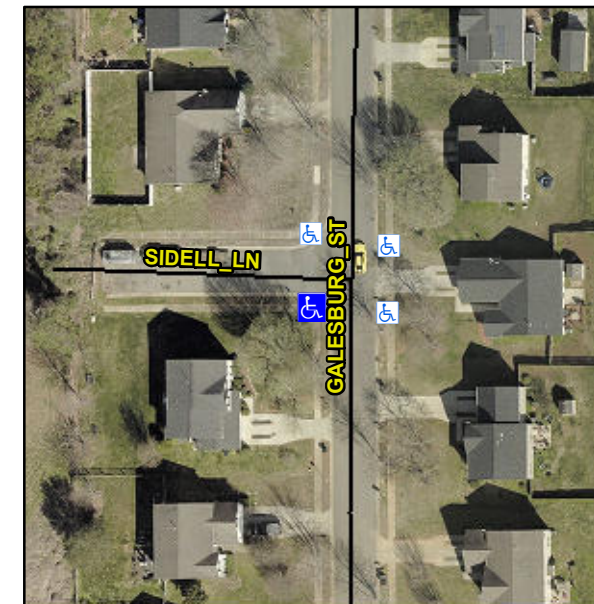
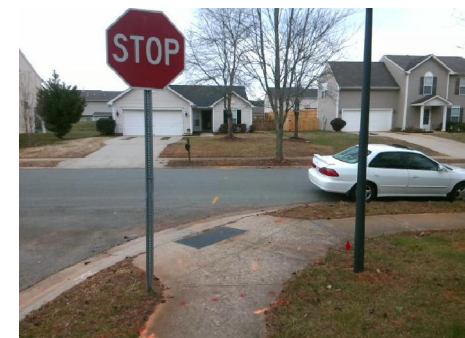
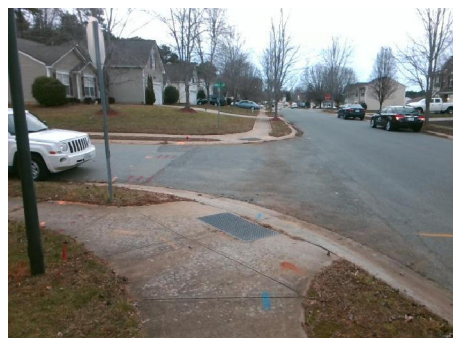
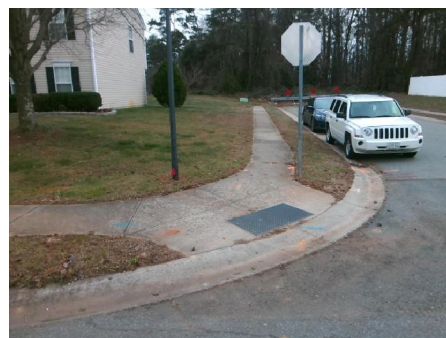
**Not Found, R304.2.1, R304.2.2-Perp, R304.3.2-Para, R304.5.3, R305.2, R304.5.4**

| Compliance | Description | Data | Compliance | Description | Data |
|---|---|---|---|---|---|
| No | Landing Length (in) | 45.5 | Yes | DWS Provided? | Yes |
| No | Landing Slope (%) | 2.9 | Yes | DWS Length (in) | 25.5 |
| No | Landing X Slope (%) | 4.4 | Yes | DWS Full Width? | Yes |
| N/A | Landing Curb? (Y/N) | No | No | DWS Offset (in) | 3.0 |
| Yes | Gutter Ponding? | No | No | Gutter Slope (%) | 6.7 |

**Remove & Replace Curb Ramp With Two New Directional Ramps or Equivalent. Remove & Replace Gutter.**

Total Cost: \$ 3950.00
