# Access Compliance Report

## Public Rights-of-Way

### (Curb Ramps)

Intersection ID: 18264	Main Street: S_WENDOVER_RD	Cross Street: SHARON_RD	Location: SE
ADA ID: 55879B2273E5	Ramp Type: MedianPerp	Initial Pass/Fail: Fail	Overall Compliance: No
Severity Score: 35			
Codes/Mitigation Info/Possible Solution		Field Measurements/Component Compliance

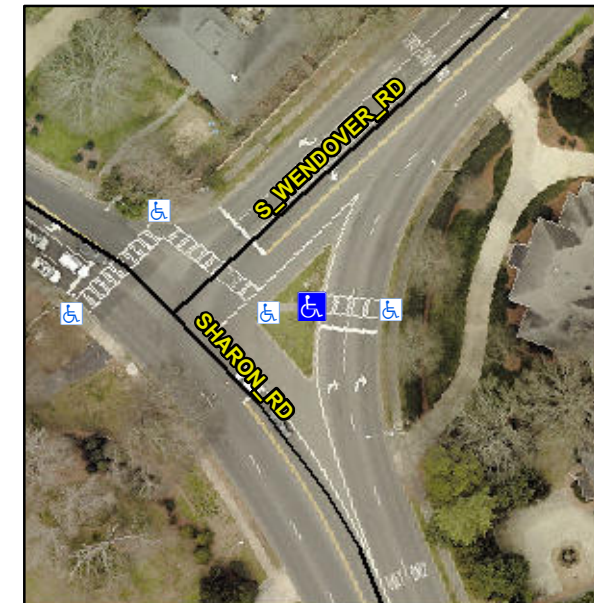
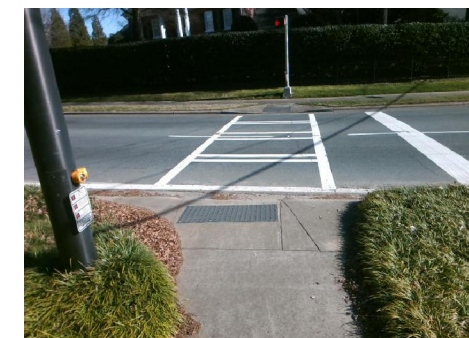
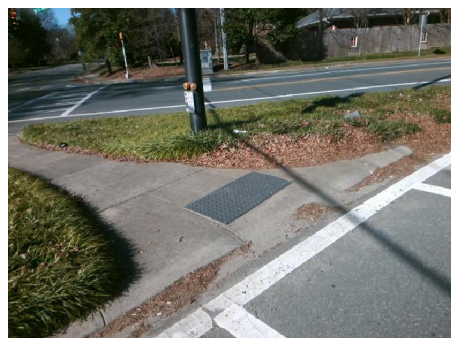
**R304.5.1, R304.2.2, R304.5.3**

Compliance	Description	Data	Compliance	Description	Data
N/A	Ramp Length (in)	65.0	No	Ramp Slope (%)	12.4
No	Ramp Width (in)	41.0	No	Ramp XSlope (%)	4.7
N/A	Flare Type LT	N/A	N/A	Flare Type RT	N/A
N/A	Flare Slope LT (%)	N/A	N/A	Flare Slope RT (%)	N/A
N/A	Flare Traversable LT?	N/A	N/A	Flare Traversable RT?	N/A
N/A	Landing Length (in)	N/A	N/A	DWS Provided?	N/A
N/A	Landing Width (in)	N/A	N/A	DWS Contrast?	N/A
N/A	Landing Slope (%)	N/A	N/A	DWS Length (in)	N/A
N/A	Landing X Slope (%)	N/A	N/A	DWS Full Width?	N/A
N/A	Landing Curb? (Y/N)	N/A	N/A	DWS Offset (in)	N/A
N/A	Shared Landing?	N/A			
N/A	Gutter Ponding?	N/A	N/A	Gutter Slope (%)	N/A
N/A	Gutter Lip Ht (in)	N/A	N/A	Gutter X Slope (%)	N/A
N/A	Painted X Walk1?	Yes	N/A	Painted X Walk2?	N/A
	X Walk 1 Direction	To SE		X Walk 2 Direction	N/A
N/A	X Walk 1 Width (in)	103.0	N/A	X Walk 2 Width (in)	N/A
	X Walk 1 Slope (%)	4.3		X Walk 2 Slope (%)	N/A
	X Walk 1 X Slope (%)	4.4		X Walk 2 X Slope (%)	N/A

N/A	Ramp inside XWalk1?	Yes	N/A	Ramp inside XWalk2?	N/A
	Road Slope (%)	N/A	N/A	Clear Space?	N/A
	Road X Slope (%)	N/A	N/A	Clear Space to XWalk (in)	N/A
N/A	Any Obstructions?	N/A	N/A	Storm Grate/Utility Hazard?	N/A
	Obstruction Type			Storm Grate/Utility Type	
		N/A			N/A
			Yes	Surface Condition? (G/P)	Good

**Remove & Replace Entire Ramp.**
