Access Compliance Report

Public Rights-of-Way

(Curb Ramps)

Intersection ID: 49505	Main Street: ADEL_LN	Cross Street: OSCEOLA_LN	Location: NW
ADA ID: 558D73E9C73F	Ramp Type: Perp	Initial Pass/Fail: Fail	Overall Compliance: No
		Severity Score: 10

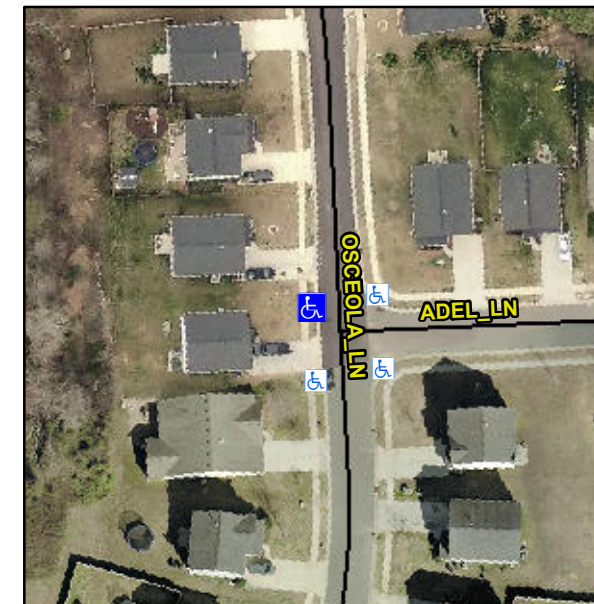
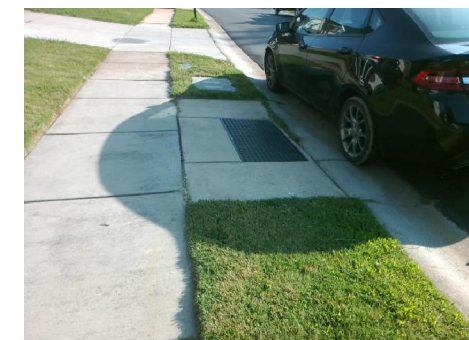
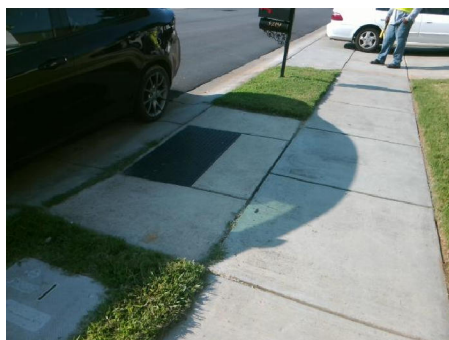
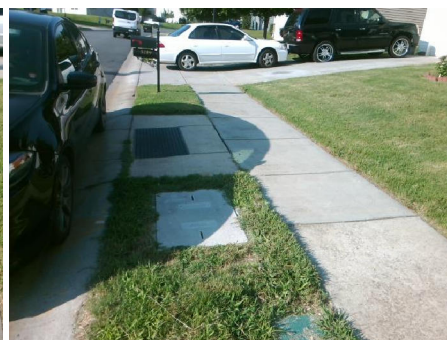
Not Found, R304.5.1, R304.5.3

Compliance	Description	Data	Compliance	Description	Data
N/A	Ramp Length (in)	48.0	Yes	Ramp Slope (%)	8.3
No	Ramp Width (in)	47.5	No	Ramp XSlope (%)	3.5
N/A	Flare Type LT	N/A	N/A	Flare Type RT	N/A
N/A	Flare Slope LT (%)	N/A	N/A	Flare Slope RT (%)	N/A
N/A	Flare Traversable LT?	N/A	N/A	Flare Traversable RT?	N/A
N/A	Landing Length (in)	N/A	N/A	DWS Provided?	N/A
N/A	Landing Width (in)	N/A	N/A	DWS Contrast?	N/A
N/A	Landing Slope (%)	N/A	N/A	DWS Length (in)	N/A
N/A	Landing X Slope (%)	N/A	N/A	DWS Full Width?	N/A
N/A	Landing Curb? (Y/N)	N/A	N/A	DWS Offset (in)	N/A
N/A	Shared Landing?	N/A			
N/A	Gutter Ponding?	N/A	N/A	Gutter Slope (%)	N/A
N/A	Gutter Lip Ht (in)	N/A	N/A	Gutter X Slope (%)	N/A
N/A	Painted X Walk1?	No	N/A	Painted X Walk2?	N/A
	X Walk 1 Direction	To E		X Walk 2 Direction	N/A
N/A	X Walk 1 Width (in)	N/A	N/A	X Walk 2 Width (in)	N/A
	X Walk 1 Slope (%)	3.7		X Walk 2 Slope (%)	N/A
	X Walk 1 X Slope (%)	2.7		X Walk 2 X Slope (%)	N/A

N/A	Ramp inside XWalk1?	N/A	N/A	Ramp inside XWalk2?	N/A
	Road Slope (%)	N/A	N/A	Clear Space?	N/A
	Road X Slope (%)	N/A	N/A	Clear Space to XWalk (in)	N/A
N/A	Any Obstructions?	N/A	N/A	Storm Grate/Utility Hazard?	N/A
	Obstruction Type			Storm Grate/Utility Type	
		N/A			N/A
			Yes	Surface Condition? (G/P)	Good

Remove & Replace Entire Ramp.
