Access Compliance Report

Public Rights-of-Way

(Curb Ramps)

Intersection ID: N/A	Main Street: QUEENS_RD	Cross Street: LUTHER_ST	Location: NW
ADA ID: 55910FE73728	Ramp Type: Perp	Initial Pass/Fail: Fail	Overall Compliance: No
Severity Score: 37.5			
Codes/Mitigation Info/Possible Solution		Field Measurements/Component Compliance

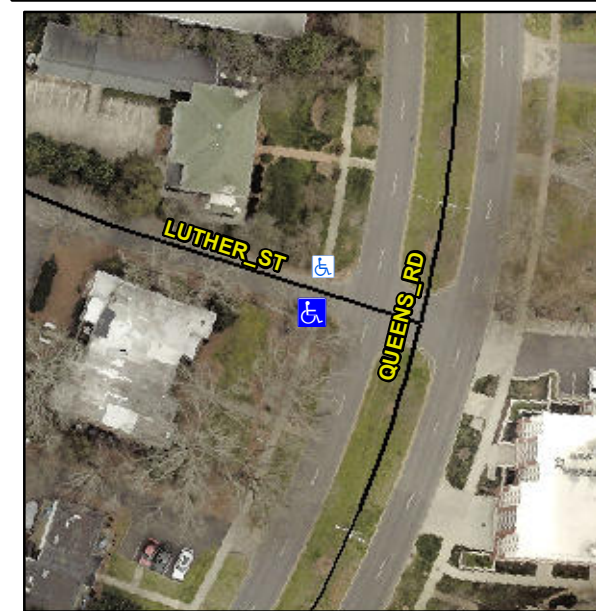
Not Found, R304.2.2, R304.5.3

Compliance	Description	Data	Compliance	Description	Data
N/A	Ramp Length (in)	41.0	No	Ramp Slope (%)	12.7
Yes	Ramp Width (in)	48.0	No	Ramp XSlope (%)	5.6
N/A	Flare Type LT	N/A	N/A	Flare Type RT	N/A
N/A	Flare Slope LT (%)	N/A	N/A	Flare Slope RT (%)	N/A
N/A	Flare Traversable LT?	N/A	N/A	Flare Traversable RT?	N/A
N/A	Landing Length (in)	N/A	N/A	DWS Provided?	N/A
N/A	Landing Width (in)	N/A	N/A	DWS Contrast?	N/A
N/A	Landing Slope (%)	N/A	N/A	DWS Length (in)	N/A
N/A	Landing X Slope (%)	N/A	N/A	DWS Full Width?	N/A
N/A	Landing Curb? (Y/N)	N/A	N/A	DWS Offset (in)	N/A
N/A	Shared Landing?	N/A			
N/A	Gutter Ponding?	N/A	N/A	Gutter Slope (%)	N/A
N/A	Gutter Lip Ht (in)	N/A	N/A	Gutter X Slope (%)	N/A
N/A	Painted X Walk1?	No	N/A	Painted X Walk2?	N/A
	X Walk 1 Direction	To NE		X Walk 2 Direction	N/A
N/A	X Walk 1 Width (in)	N/A	N/A	X Walk 2 Width (in)	N/A
	X Walk 1 Slope (%)	5.9		X Walk 2 Slope (%)	N/A
	X Walk 1 X Slope (%)	4.3		X Walk 2 X Slope (%)	N/A

N/A	Ramp inside XWalk1?	N/A	N/A	Ramp inside XWalk2?	N/A
	Road Slope (%)	N/A	N/A	Clear Space?	N/A
	Road X Slope (%)	N/A	N/A	Clear Space to XWalk (in)	N/A
N/A	Any Obstructions?	N/A	N/A	Storm Grate/Utility Hazard?	N/A
	Obstruction Type			Storm Grate/Utility Type	
		N/A			N/A
			Yes	Surface Condition? (G/P)	Good

Possible Solutions:

Remove & Replace Entire Ramp.

Total Cost: \$ 1850.00
