Access Compliance Report

Public Rights-of-Way

(Curb Ramps)

Intersection ID: 43887	Main Street: DOGGETT_ST	Cross Street: ABBOTT_ST	Location:	NE
ADA ID: 55A99738C746	Ramp Type: Directional1	Initial Pass/Fail: Fail	Overall Compliance: No	Severity Score: 37.5
Codes/Mitigation Info/Possible Solution		Field Measurements/Component Compliance

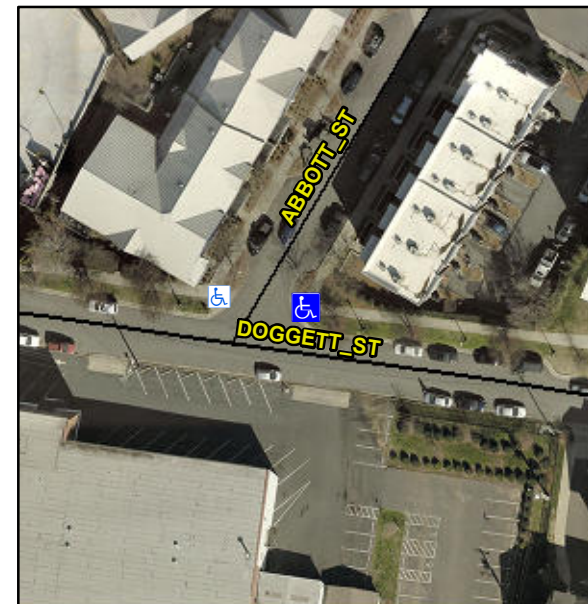
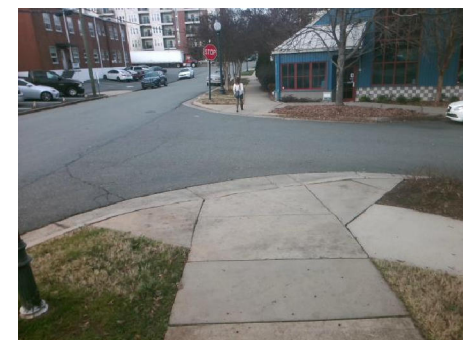
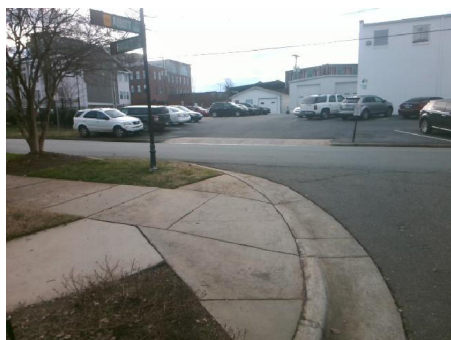
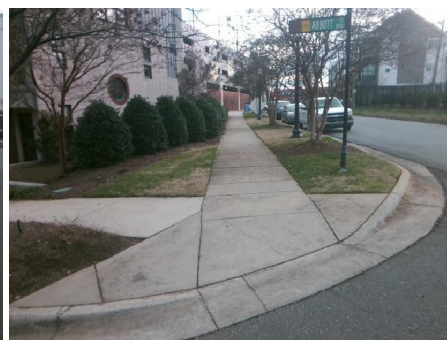
R304.2.2, R304.5.3

Compliance	Description	Data	Compliance	Description	Data
N/A	Ramp Length (in)	37.0	N/A	Grade Break?	N/A
Yes	Ramp Width (in)	70.0	N/A	Grade Break Slope (%)	0.0
No	Ramp Slope (%)	12.8	N/A	Grade Break XSlope (%)	0.0
No	Ramp XSlope (%)	5.1			
N/A	Flare Type LT	N/A	N/A	Flare Type RT	N/A
N/A	Flare Slope LT (%)	N/A	N/A	Flare Slope RT (%)	0.0
N/A	Flare Traversable LT?	N/A	N/A	Flare Traversable RT?	N/A
N/A	Landing Length (in)	0.0	N/A	DWS Provided?	N/A
N/A	Landing Width (in)	0.0	N/A	DWS Contrast?	N/A
N/A	Landing Slope (%)	0.0	N/A	DWS Length (in)	N/A
N/A	Landing X Slope (%)	0.0	N/A	DWS Full Width?	N/A
N/A	Landing Curb? (Y/N)	N/A	N/A	DWS Offset LT (in)	N/A
N/A	Shared Landing?	N/A	N/A	DWS Offset RT (in)	N/A
N/A	Gutter Ponding?	0.0	N/A	Gutter Slope (%)	N/A
N/A	Gutter Lip Ht (in)	0.0	N/A	Gutter X Slope (%)	N/A
N/A	Painted X Walk1?	No		Road Slope (%)	1.2
	X Walk 1 Direction	To W		Road X Slope (%)	8.5
	X Walk 1 Width (in)	N/A		Clear Space?	N/A

X Walk 1 Slope (%)	1.2	N/A	Clear Space to XWalk (in)	N/A
	X Walk 1 X Slope (%)	8.5	N/A	Storm Grate/Utility Hazard?	N/A
N/A	Ramp inside XWalk1?	N/A		Storm Grate/Utility Type	
N/A	Any Obstructions?	N/A			N/A
	Obstruction Type		Yes	Surface Condition? (G/P)	Good
			N/A	Curb Slope (%)	0.0

Remove & Replace Entire Ramp.

Total Cost: \$ **1600.00**
