# Access Compliance Report

## Public Rights-of-Way

### (Curb Ramps)

Intersection ID: 44008	Main Street: ARCOLA_LN	Cross Street: DEMAINE_DR	Location:	N
ADA ID: 55B8E556AC2A	Ramp Type: BlendTrans2	Initial Pass/Fail: Fail	Overall Compliance: No	Severity Score: 17.5
Codes/Mitigation Info/Possible Solution		Field Measurements/Component Compliance

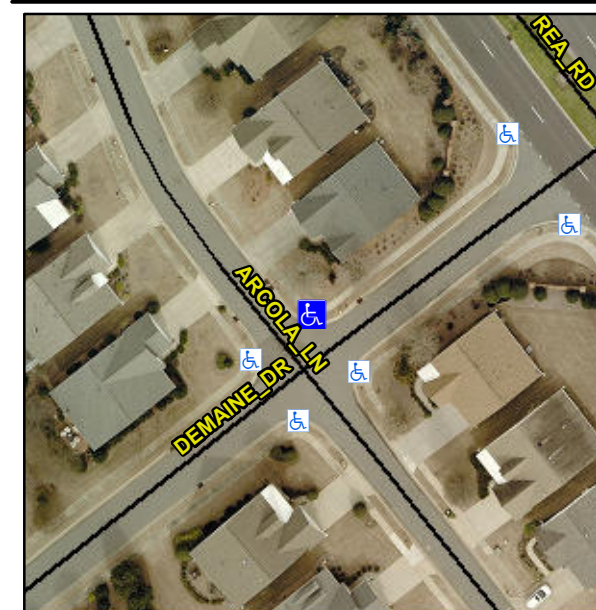
**Not Found, R304.5.1**

Compliance	Description	Data	Compliance	Description	Data
N/A	Ramp Length (in)	96.0	Yes	BlendTrans Slope (%)	4.9
No	Ramp Width (in)	34.0	Yes	BlendTrans XSlope (%)	1.5
N/A	Flare Type LT	N/A	N/A	Flare Type RT	N/A
N/A	Flare Slope LT (%)	N/A	N/A	Flare Slope RT (%)	N/A
N/A	Flare Traversable LT?	N/A	N/A	Flare Traversable RT?	N/A
N/A	Landing Length (in)	N/A	N/A	DWS Provided?	N/A
N/A	Landing Width (in)	N/A	N/A	DWS Contrast?	N/A
N/A	Landing Slope (%)	N/A	N/A	DWS Length (in)	N/A
N/A	Landing X Slope (%)	N/A	N/A	DWS Full Width?	N/A
N/A	Landing Curb? (Y/N)	N/A	N/A	DWS Offset (in)	N/A
N/A	Shared Landing?	N/A			
N/A	Gutter Ponding?	N/A	N/A	Gutter Slope (%)	N/A
N/A	Gutter Lip Ht (in)	N/A	N/A	Gutter X Slope (%)	N/A
N/A	Painted X Walk1?	No	N/A	Painted X Walk2?	No
	X Walk 1 Direction	To SW		X Walk 2 Direction	To SE
	X Walk 1 Width (in)	N/A		X Walk 2 Width (in)	N/A
	X Walk 1 Slope (%)	1.0		X Walk 2 Slope (%)	3.3
	X Walk 1 X Slope (%)	0.1		X Walk 2 X Slope (%)	2.9

N/A	Ramp inside XWalk1?	N/A	N/A	Ramp inside XWalk2?	N/A
	Road Slope (%)	2.8		Clear Space?	N/A
	Road X Slope (%)	0.8	N/A	Clear Space to XWalk (in)	N/A
N/A	Any Obstructions?	N/A	N/A	Storm Grate/Utility Hazard?	N/A
	Obstruction Type			Storm Grate/Utility Type	
		N/A			N/A
			Yes	Surface Condition? (G/P)	Good
			No	Curb Slope (%)	21.9

**Remove & Replace Curb Ramp With Two New Directional Ramps or Equivalent.**
