Access Compliance Report

Public Rights-of-Way

(Curb Ramps)

Intersection ID: 17085	Main Street: CROYDON_RD	Cross Street: SELWYN_AV	Location: SE
ADA ID: 55C103A189F1	Ramp Type: PerpDiag	Initial Pass/Fail: Fail	Overall Compliance: No
Severity Score: 12.5			
Codes/Mitigation Info/Possible Solution		Field Measurements/Component Compliance

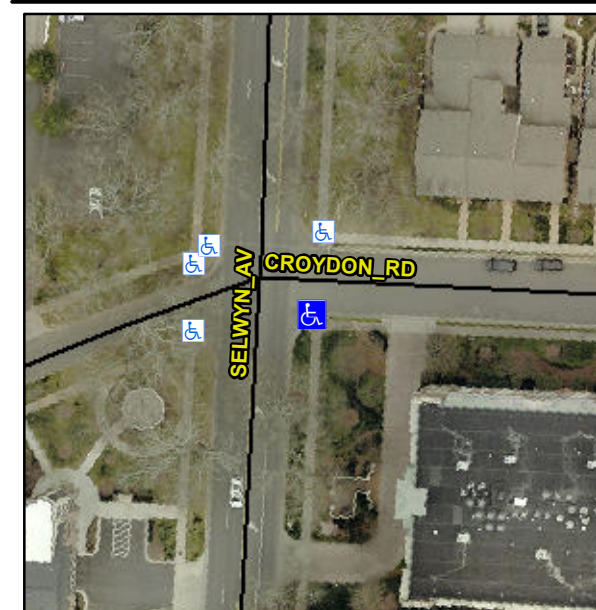
Compliance	Description	Data	Compliance	Description	Data
N/A	Ramp Length (in)	79.0	Yes	Ramp Slope (%)	7.7
Yes	Ramp Width (in)	51.0	No	Ramp XSlope (%)	5.4
N/A	Flare Type LT	N/A	N/A	Flare Type RT	N/A
N/A	Flare Slope LT (%)	N/A	N/A	Flare Slope RT (%)	N/A
N/A	Flare Traversable LT?	N/A	N/A	Flare Traversable RT?	N/A
N/A	Landing Length (in)	N/A	N/A	DWS Provided?	N/A
N/A	Landing Width (in)	N/A	N/A	DWS Contrast?	N/A
N/A	Landing Slope (%)	N/A	N/A	DWS Length (in)	N/A
N/A	Landing X Slope (%)	N/A	N/A	DWS Full Width?	N/A
N/A	Landing Curb? (Y/N)	N/A	N/A	DWS Offset (in)	N/A
N/A	Shared Landing?	N/A			
N/A	Gutter Ponding?	N/A	N/A	Gutter Slope (%)	N/A
N/A	Gutter Lip Ht (in)	1.5	N/A	Gutter X Slope (%)	N/A
N/A	Painted X Walk1?	No	N/A	Painted X Walk2?	No
	X Walk 1 Direction	To NE		X Walk 2 Direction	To W
N/A	X Walk 1 Width (in)	N/A	N/A	X Walk 2 Width (in)	N/A
	X Walk 1 Slope (%)	3.2		X Walk 2 Slope (%)	1.1
	X Walk 1 X Slope (%)	3.5		X Walk 2 X Slope (%)	0.7

N/A	Ramp inside XWalk1?	N/A	N/A	Ramp inside XWalk2?	N/A
	Road Slope (%)	5.0	N/A	Clear Space?	N/A
	Road X Slope (%)	0.3	N/A	Clear Space to XWalk (in)	N/A
N/A	Any Obstructions?	N/A	N/A	Storm Grate/Utility Hazard?	N/A
	Obstruction Type			Storm Grate/Utility Type	
		N/A			N/A
		Yes		Surface Condition? (G/P)	Good

Possible Solutions:

Remove & Replace Curb Ramp With Two New Directional Ramps or Equivalent.

R304.5.3

Total Cost: \$ 3200.00
