Access Compliance Report

Public Rights-of-Way

(Curb Ramps)

Intersection ID: 3373	Main Street: KATELYN_DR	Cross Street: PROSPERITY_CHURCH_RD	Location:	N
ADA ID: 55C1A0ACD5F5	Ramp Type: Perp	Initial Pass/Fail: Fail	Overall Compliance: No	Severity Score: 46.25
Codes/Mitigation Info/Possible Solution		Field Measurements/Component Compliance

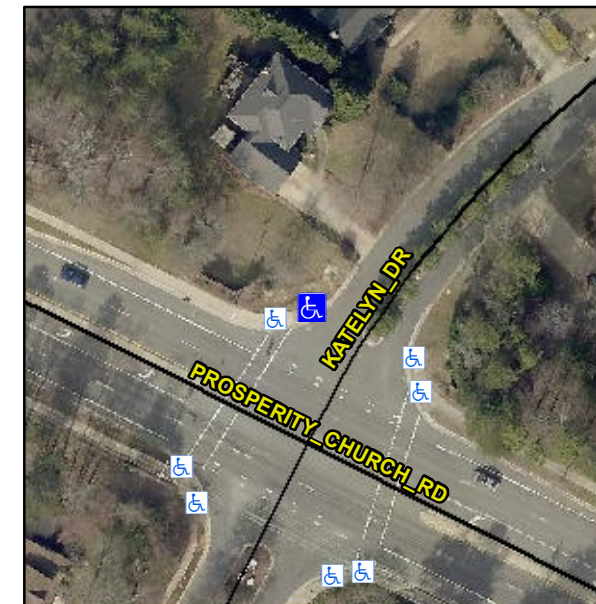
Compliance	Description	Data	Compliance	Description	Data
N/A	Ramp Length (in)	72.0	No	Ramp Slope (%)	9.1
No	Ramp Width (in)	38.0	No	Ramp XSlope (%)	8.2
N/A	Flare Type LT	N/A	N/A	Flare Type RT	N/A
N/A	Flare Slope LT (%)	N/A	N/A	Flare Slope RT (%)	N/A
N/A	Flare Traversable LT?	N/A	N/A	Flare Traversable RT?	N/A
N/A	Landing Length (in)	N/A	N/A	DWS Provided?	N/A
N/A	Landing Width (in)	N/A	N/A	DWS Contrast?	N/A
N/A	Landing Slope (%)	N/A	N/A	DWS Length (in)	N/A
N/A	Landing X Slope (%)	N/A	N/A	DWS Full Width?	N/A
N/A	Landing Curb? (Y/N)	N/A	N/A	DWS Offset (in)	N/A
N/A	Shared Landing?	N/A			
N/A	Gutter Ponding?	N/A	N/A	Gutter Slope (%)	N/A
N/A	Gutter Lip Ht (in)	1.5	N/A	Gutter X Slope (%)	N/A
N/A	Painted X Walk1?	No	N/A	Painted X Walk2?	N/A
	X Walk 1 Direction	To SE		X Walk 2 Direction	N/A
N/A	X Walk 1 Width (in)	N/A	N/A	X Walk 2 Width (in)	N/A
	X Walk 1 Slope (%)	0.3		X Walk 2 Slope (%)	N/A
	X Walk 1 X Slope (%)	7.0		X Walk 2 X Slope (%)	N/A

N/A	Ramp inside XWalk1?	N/A	N/A	Ramp inside XWalk2?	N/A
	Road Slope (%)	N/A	N/A	Clear Space?	N/A
	Road X Slope (%)	N/A	N/A	Clear Space to XWalk (in)	N/A
N/A	Any Obstructions?	N/A	N/A	Storm Grate/Utility Hazard?	N/A
	Obstruction Type			Storm Grate/Utility Type	
		N/A			N/A
			Yes	Surface Condition? (G/P)	Good

Possible Solutions:

Remove & Replace Entire Ramp.

R304.5.1, R304.2.2, R304.5.3
